## EDTI ASSET ASSESSMENT – MAJOR EQUIPMENT KENNEDALE SUBSTATION

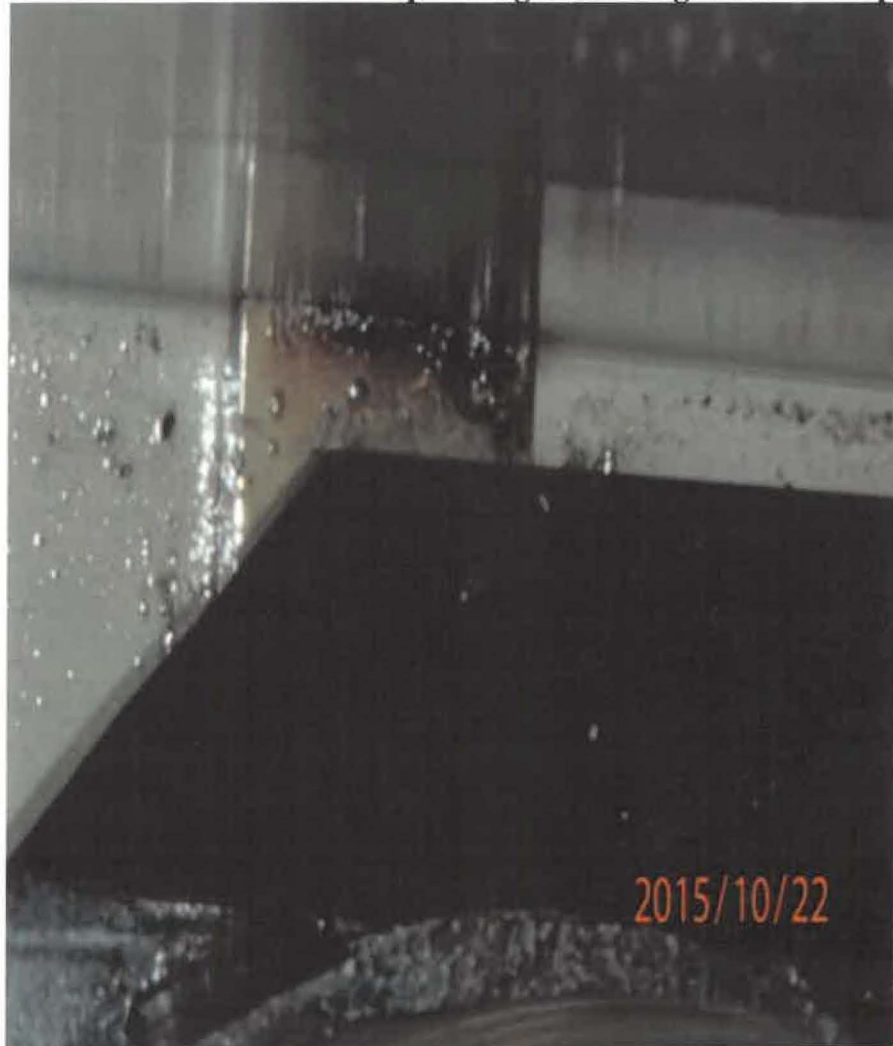
**Figure 2**  
**Kennedale Tx1 - Carbon build up and signs of arcing on reactor support**

- In 2015, a significant spike in hot metal and arcing gasses appeared, prompting an immediate internal inspection by EDTI. The inspection found signs of arcing on the support structure of the load tapchanger (LTC) reactor (Figure 2), as well as signs of overheating on the core top yoke center joint and on one of the core tie rods (Figure 3). A copper strap was added to bond the LTC reactor support and the core tie rods were tightened. Gas levels returned to normal after the repairs.

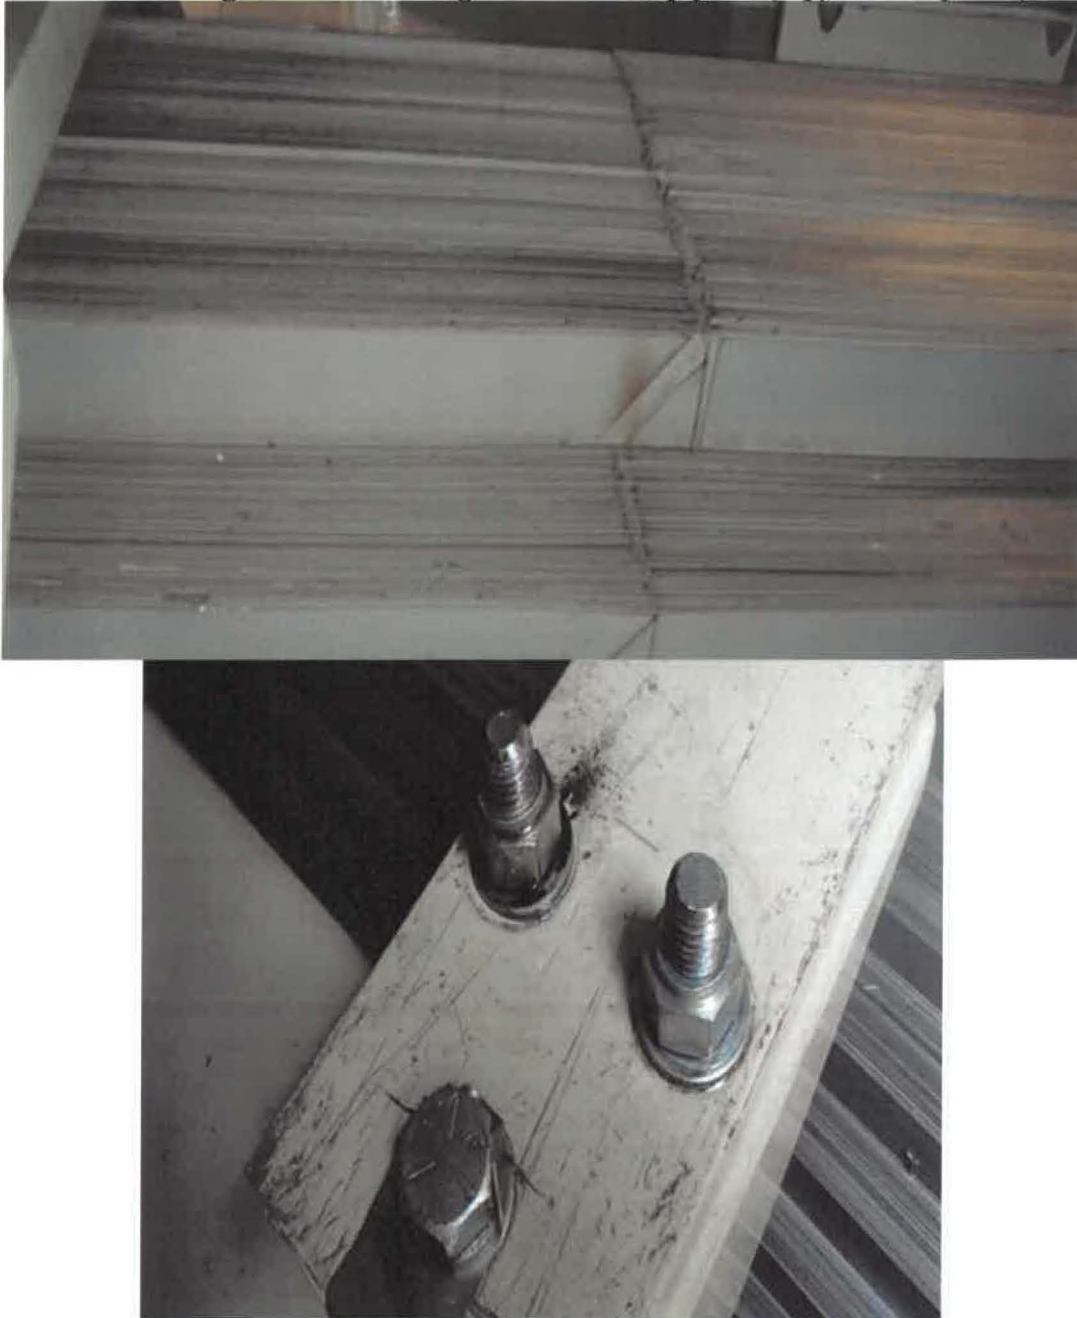
**Figure 3**  
**Kennedale Tx1 - Signs of overheating on the core top yoke (top) and tie plate (bottom)**

- The signs of overheating on the core top yoke center joint were relatively minor and unable to be economically addressed during the internal repair work. This may be the source of the lingering low-level Ethylene concentrations.

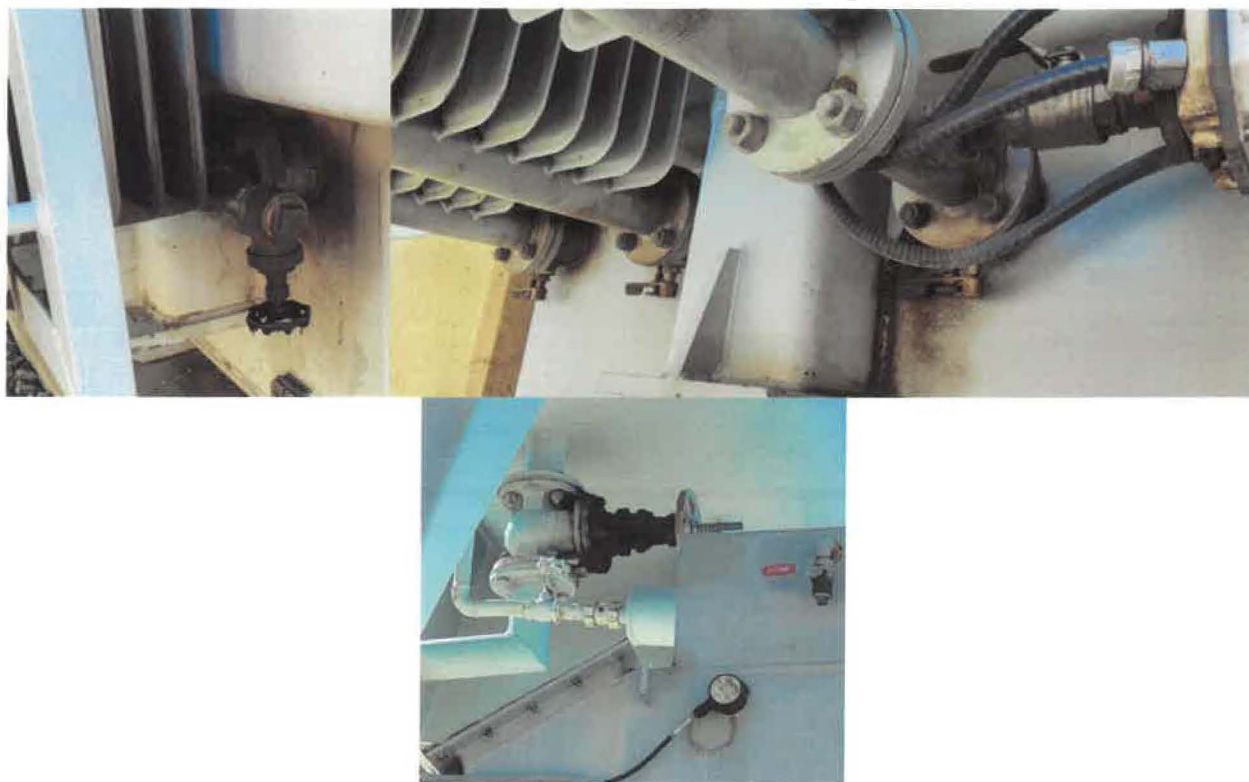
**Figure 4**  
**Kennedale Tx1 - Various minor leak points**

The transformer is also generally leak-free. There are points of slight weeping or sweating coming from various valves around the main tank such as the conservator shut-off valve and some of the radiator valves (Figure 4), however nothing is actively dripping or contacting the transformer pad or ground. The interface between the main tank and the tapchanger compartment also has signs of sweating along the bottom of the flange (Figure 5); this connection would be extremely expensive and labor intensive to access and repair, however at this time no action is required. In general, all noted leaks around the transformer are minor and do not require immediate attention.

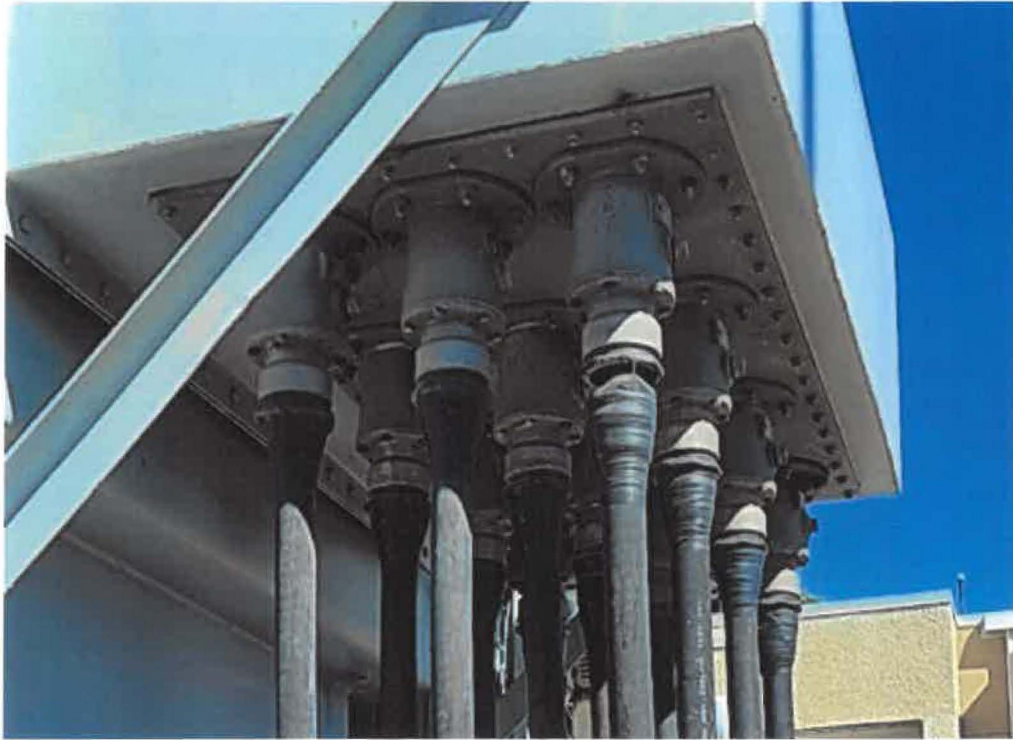
**Figure 6**  
**Kennedale Tx1 - MV cables**

Finally, the low voltage cable connections on Kennedale Tx1 are showing signs of deterioration. The connection style is obsolete by modern practice, using small potheads<sup>1</sup> to enter the LV air box before connecting to bus bar and the LV bushings. Figure 6 shows the current state of the connections, with the compound in the connection nearest to the camera having already deteriorated, resulting in a gap in the insulation forming between the cable and the pothead on the cabinet. Further degradation of the connection will require the cable to be replaced. This would be a significant undertaking, requiring long outages to remove the existing cable, pull in new cable, and terminate this cable at the transformer and switchgear ends before testing and re-energizing the transformer.

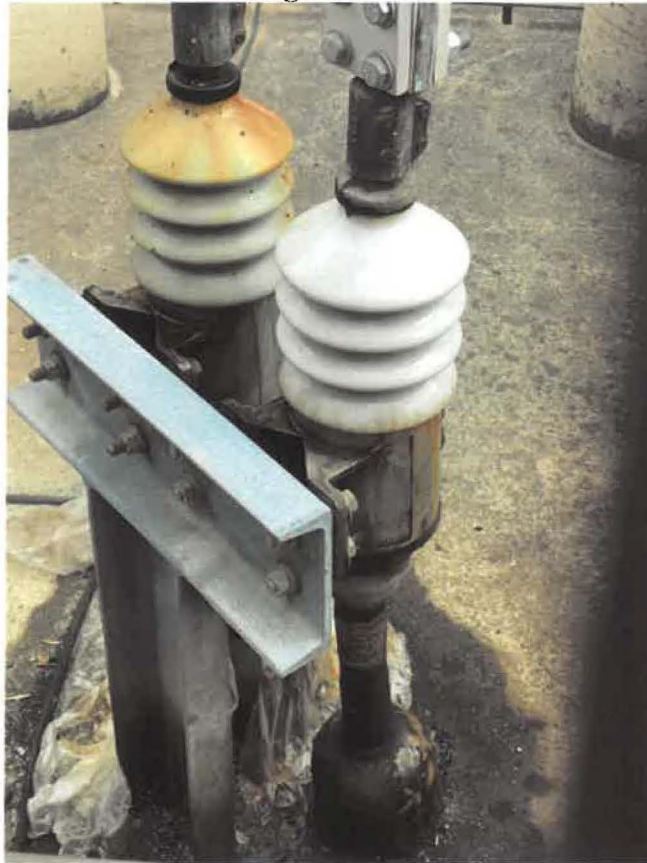
**Figure 11**  
**Leaking PILC Cables**

- The cable terminations at Kennedale are filled with a petroleum based compound which is used as insulation. Due to poor sealing and cracks in the cable and pothead, EDTI has experienced failures as the petroleum based compound has leaked out of the cable (see Figure 12 below from Kennedale). In addition, this compound can dry up if it penetrates into the paper insulation and into the conductor. Without adequate insulation it is likely that the cable will fail (as experienced by EDTI and shown in Figure 13 from Kennedale). As XLPE cables use cross-linked polyethylene as insulation, the risk of cable failure due to an inadequate amount of insulation is reduced. Further, repairing PILC cables requires specialized skills and typically costs 5 to 10 times more than repairing XLPE cables, in EDTI's experience.

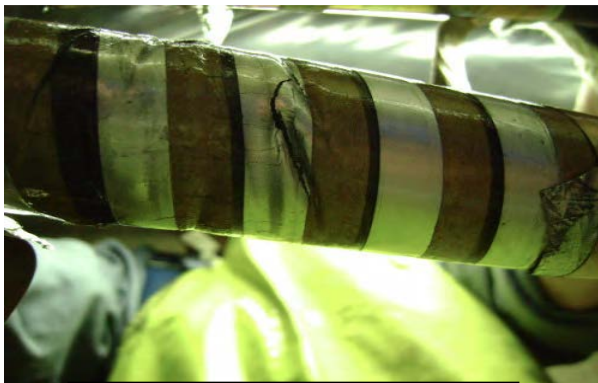
Cable shielding damage Manhole #5

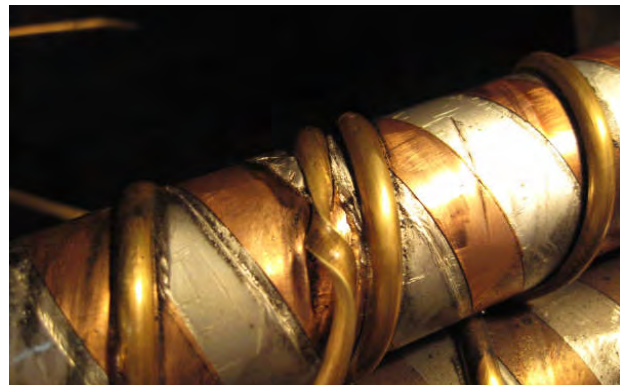
Twisted skid wire and damaged shielding tapes, Manhole #2

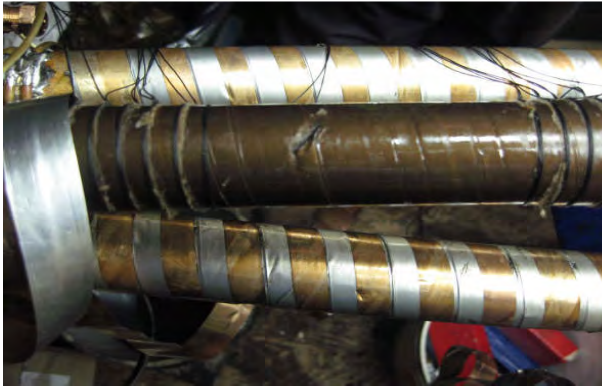
**Damaged outer insulation layers, Manhole #2**

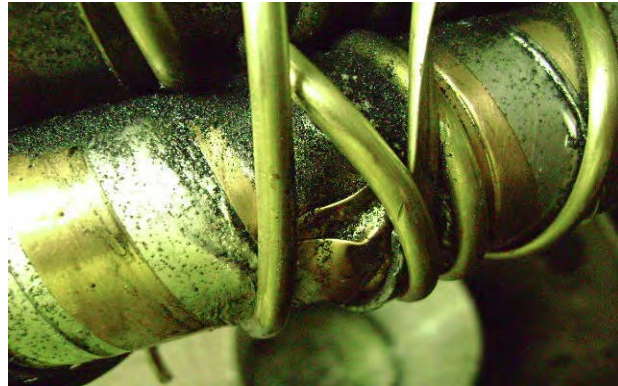
**Metal filings and loose skid wires, Manhole #5**

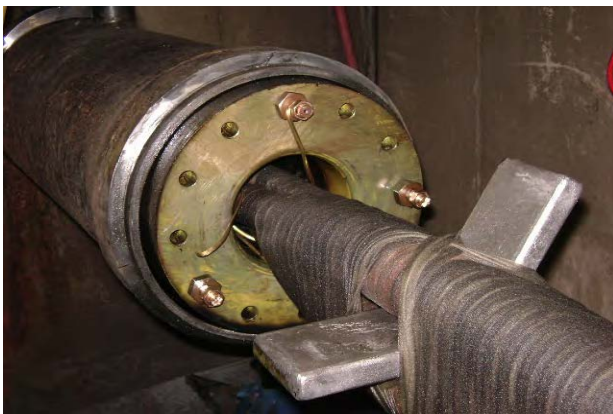
**Two skid wire ends not connected to flange of joint casing. Manhole #S6**

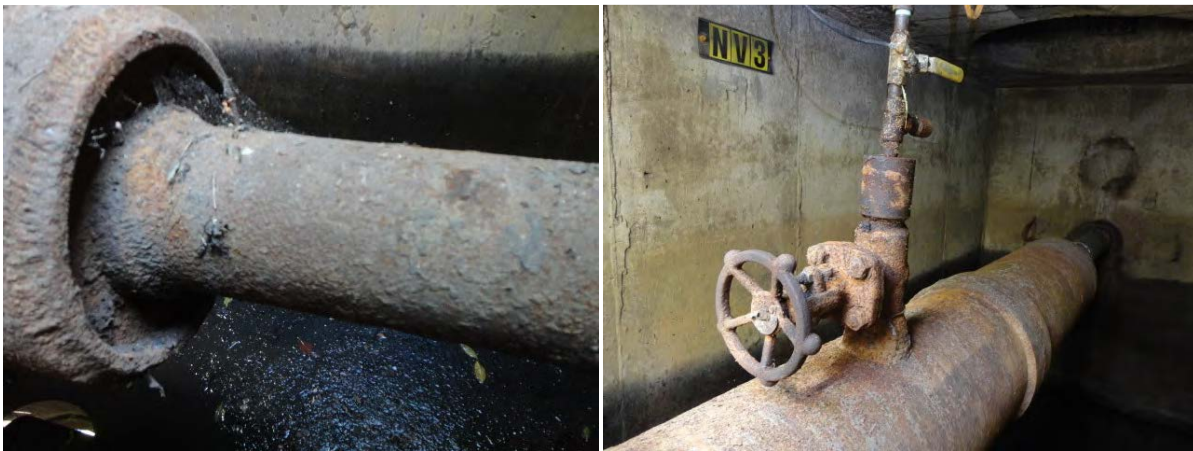
During the manholes inspection, it was generally observed that the pipe entrance to the manholes is not sealed with grout or concrete but stabilized in the centre of the opening with wooden wedges. It was observed that the pipe covering was disturbed in such places and the exposed pipe corroded.
