## EDTI ASSET ASSESSMENT – MAJOR EQUIPMENT KENNEDALE SUBSTATION

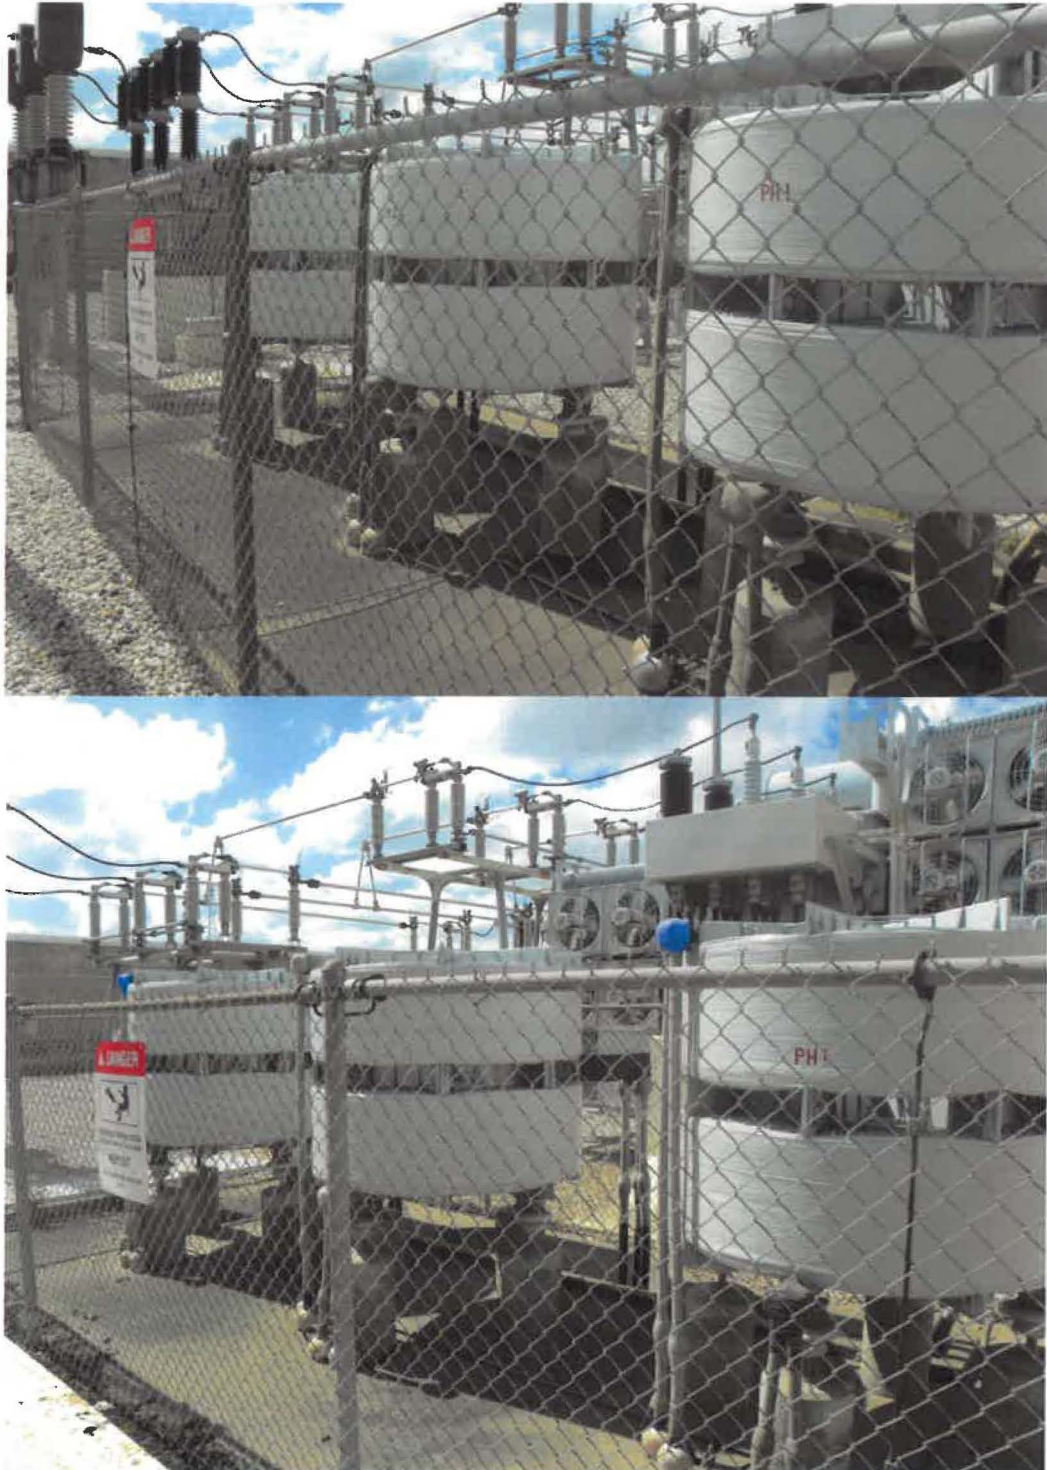
**Figure 9**  
**Kennedale Tx1 (Top) and Tx2 (Bottom) Dry Type Reactors**

Kennedale Tx1 and Tx2 each have a bank of dry type reactors connected in series to the low voltage terminals, seen in Figure 9. These dry type reactors are original to the substation, manufactured in 1973 and aged 49 years as of 2022. The manufacturer expected lifespan of a dry type reactor is 25 years at rated current. Due to the limitations of design accuracy in the era, these reactors were manufactured, inherent to the use of hand calculations rather than computer models such as those used in present-day design, design margins were considerably larger than they are currently, and seeing dry type reactors of this era exceed the expected lifespan is not uncommon. Despite this, the recommended lifespan from the manufacturer remains at 25 years, regardless of the year of manufacture.

The design and installation of dry type reactors is such that their condition cannot be assessed by electrical tests in the field. Condition assessment of the winding insulation is limited to physical inspection for damage, fouling, or deterioration. Minor damage and deterioration can be repaired in the field to an extent, and fouling can be cleaned, if routine inspections detect the deficiency

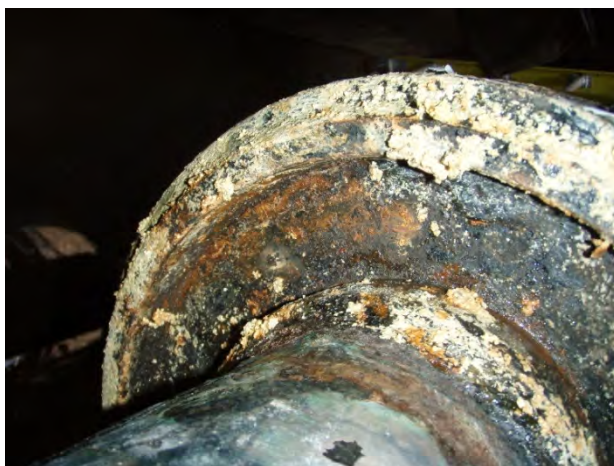
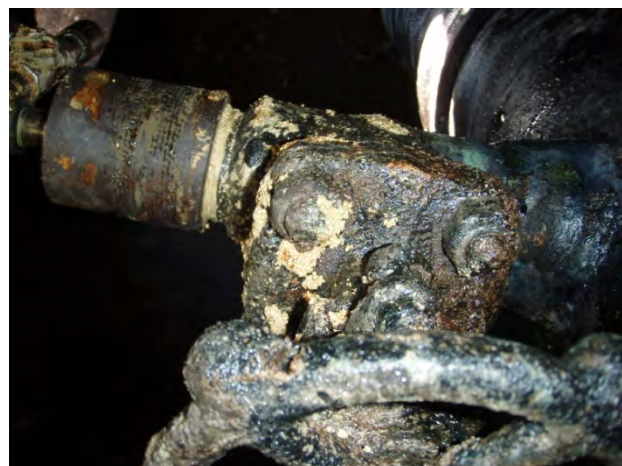
**Figure 3-1**

**Photographs from 72kV circuit VN21 taken in 2008**

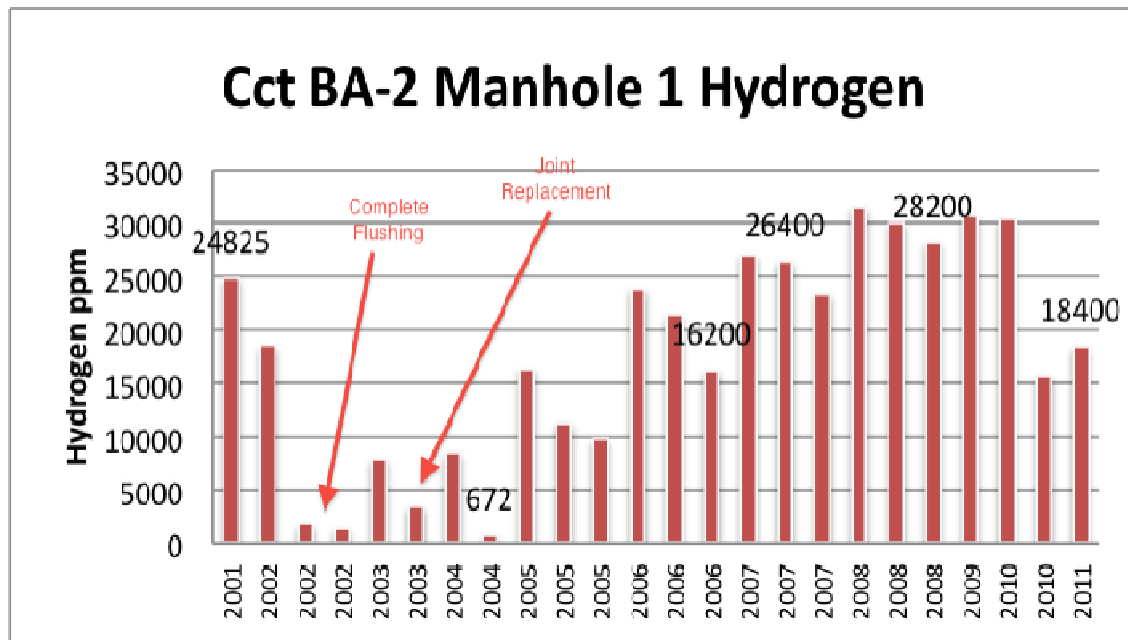
The following graph for circuit BA-2 at manhole #1 shows the trend in hydrogen over an eleven-year period. The fluid in this cable was completely flushed in 2002 / 2003. The cable joint was replaced in 2003. It is understood that some partial flushing of the fluid was carried out in 2010, although the full scope of that work is not clear from the available records.

The graphs from circuits BA2 and RS5 demonstrate that the processes responsible for hydrogen production have continued in these cables despite the joint remedial work and, in the case of circuit BA2, fluid flushing. Furthermore, the DGA results demonstrate that the combustible gases other than hydrogen have been within a “normal” range and have not shown a tendency to increase. These observations appear to validate the guidance in the EPRI Guideline that hydrogen can be produced in HPFF cables in the space between the shielded cables and the pipe wall. Such a process would not involve the cable insulation un-

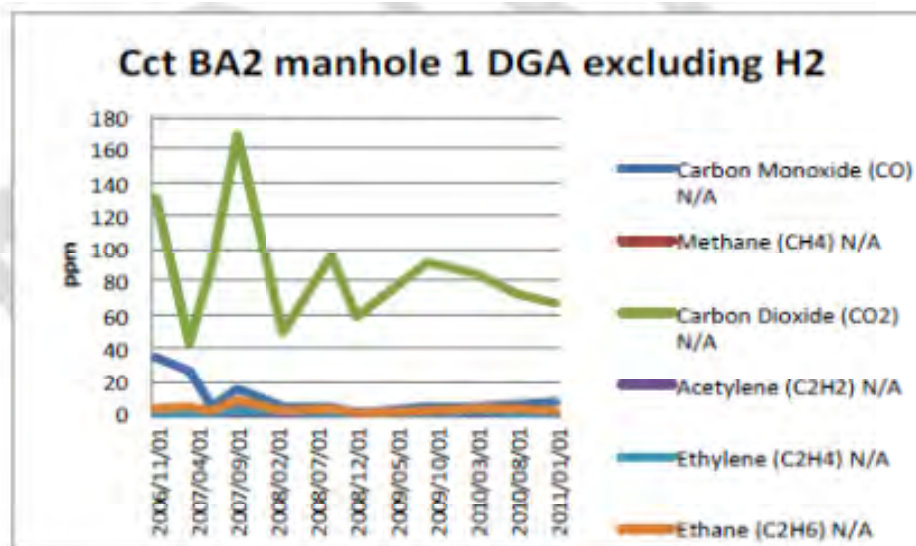
The following graph shows the DGA results for gases other than hydrogen at manhole 1 of circuit BA-2. It can be seen that at the same time as the hydrogen results at this manhole were climbing, all of the other gases continued to be within a range considered to be “normal” for a cable of this age.

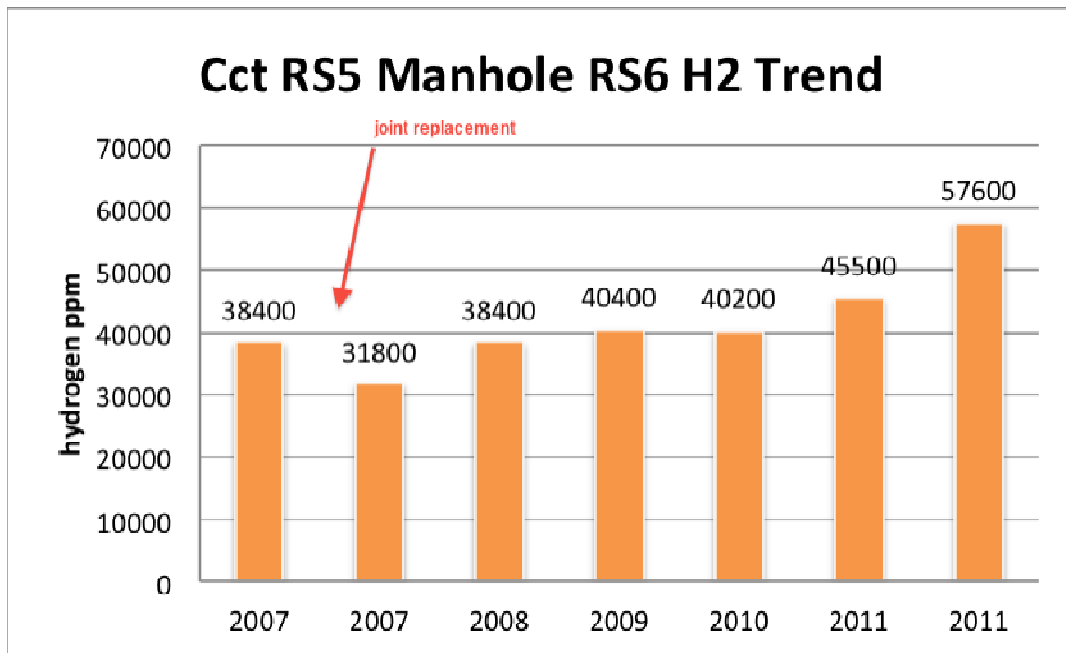
All of the joints of cable circuit RS5 were replaced in late 2007 and early 2008. When that work was undertaken it was found that the manhole with the highest concentration of hydrogen was manhole RS6. The following graph shows the variation in hydrogen levels since December 2007.

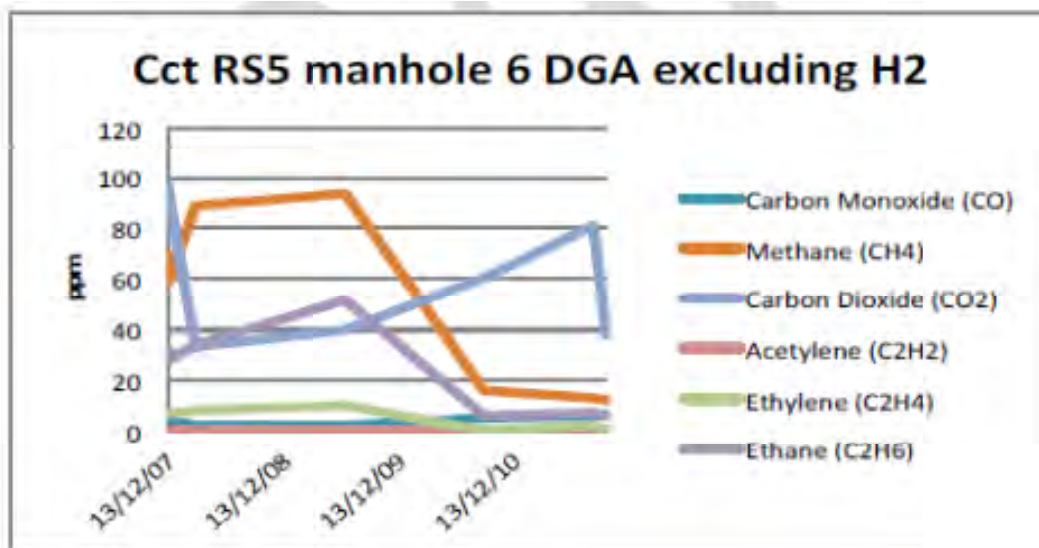
The following graph shows the DGA results for gases other than hydrogen at manhole RS6 of circuit RS-5. It can be seen that at the same time as the hydrogen results at this manhole were climbing, all of the other gases were within a range considered to be “normal” for a cable of this age.

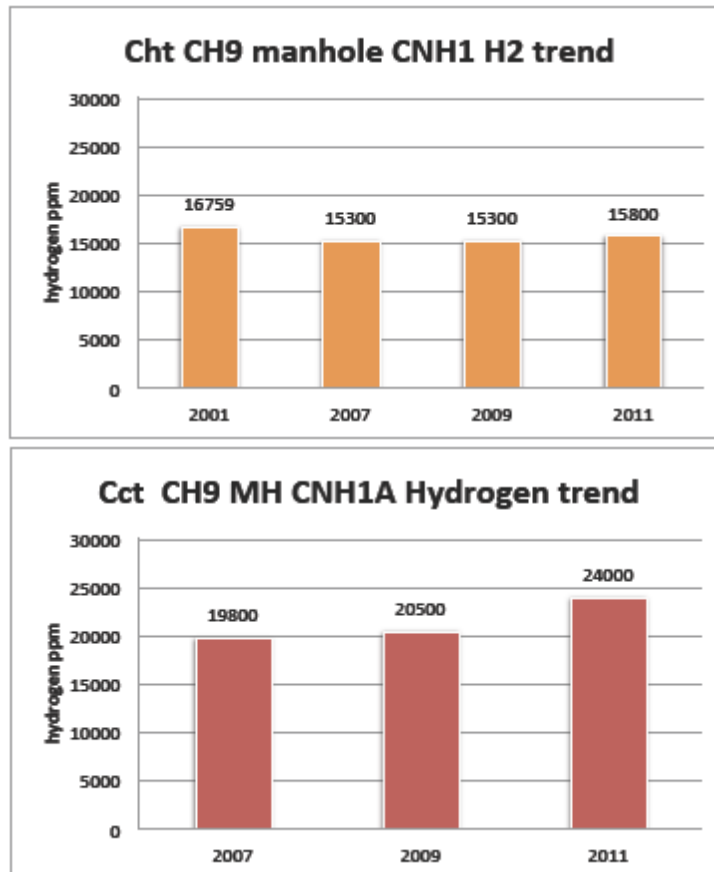
### Circuit 72CH9 Trends

A sample taken in 2011 at one of the Hardisty terminations was marginally above the “concern” upper level for hydrogen. The other two termination samples were at slightly lower values. Concentrations of the other telltale gases have been stable at the terminations.

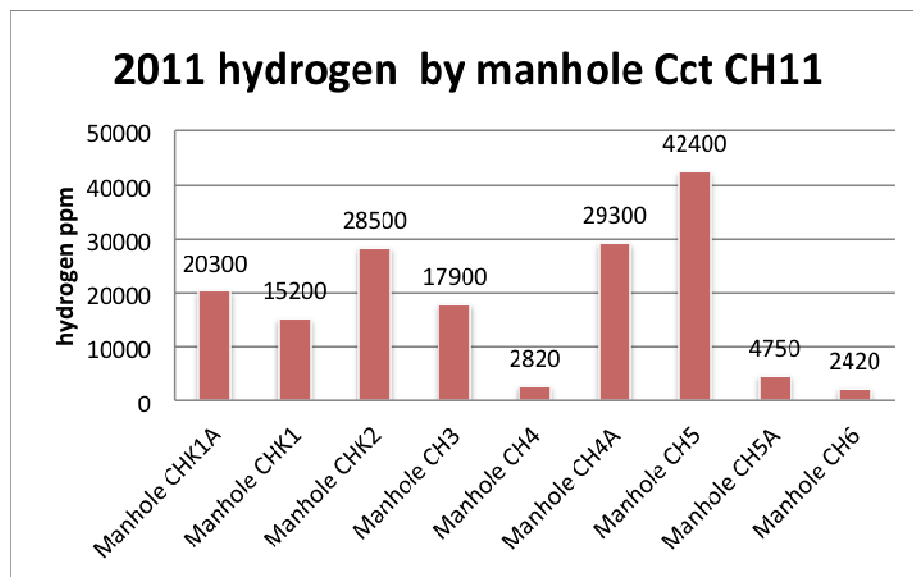
### Circuit 72CH11Trends

The hydrogen levels at the Cloverbar and Hardisty terminations are in the EPRI “concern” level with the exception of one termination at Hardisty where the hydrogen level is just above the “action” threshold. All other gases at these terminations are within the EPRI acceptable ranges.

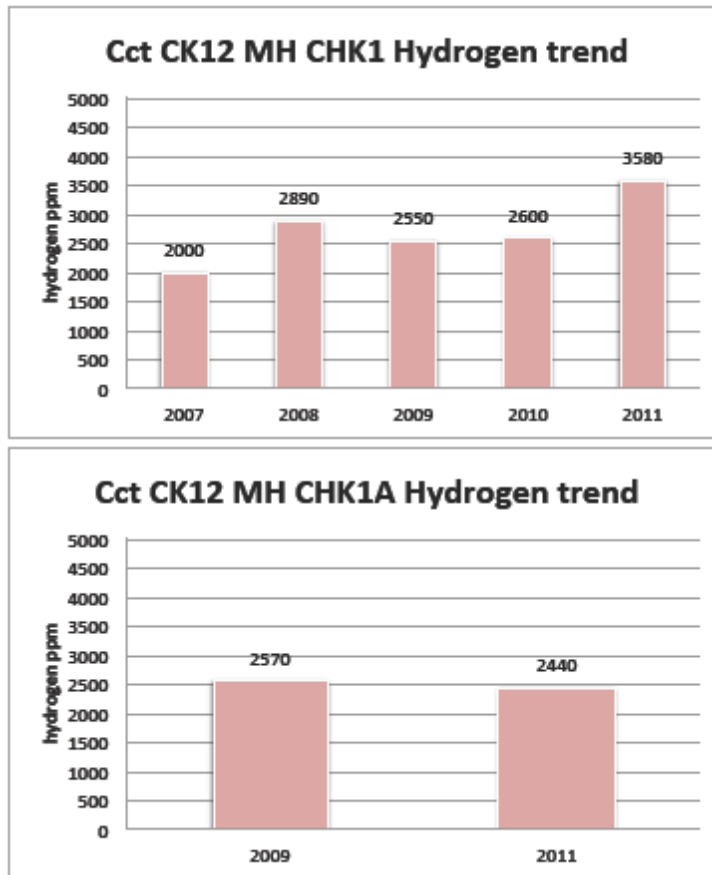
## Circuit 72CK12 Trends

The hydrogen concentrations at all of the CK12 terminations are at the “concern” level in the EPRI Guidelines. All of the other gases are relatively stable at satisfactory levels given the age of the system.

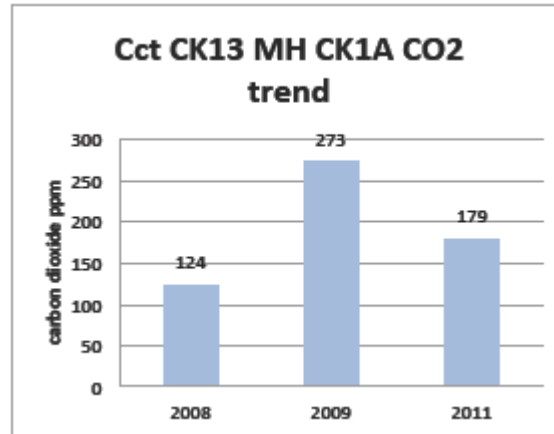
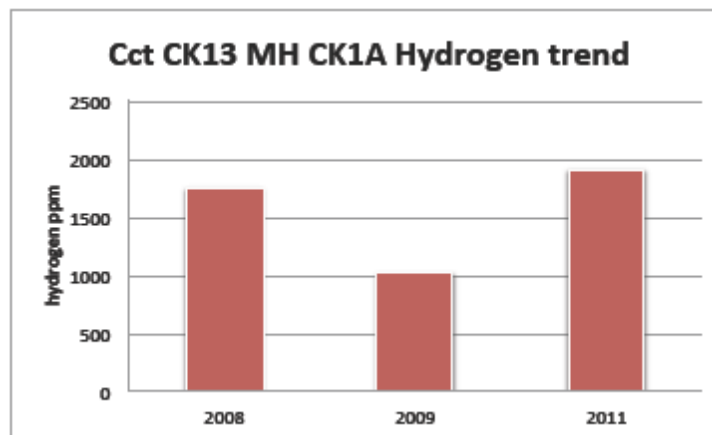
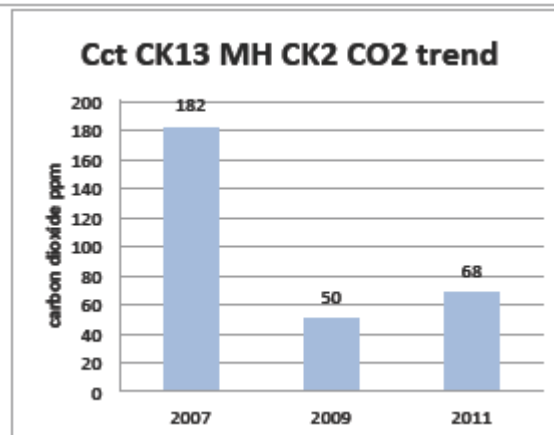
## Circuit 72CK13 Trends

The hydrogen concentrations at all of the terminations are at, or close to, the “concern” level of the EPRI Guidelines.

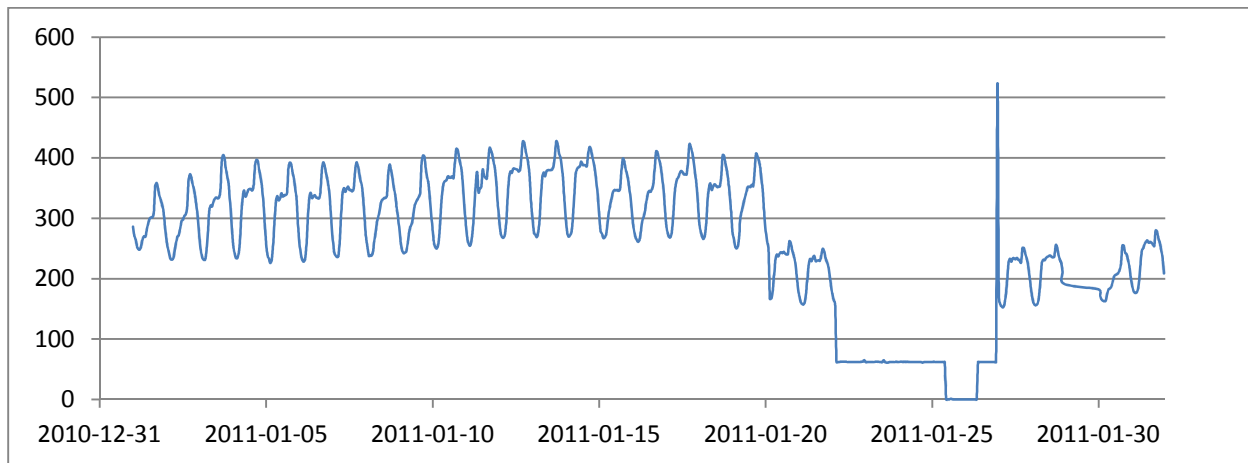
The load history was provided by EPCOR from Jan. 1999 to the present. There is no sign of circuit overheating. The maximum daily circuit load is within 60-80% of EPCOR's existing operating cable ratings. The chart below shows a typical pattern with one short duration load spike which exceeds the emergency rating.

If compared to the recommended ratings the load seems to exceed them. However, to establish the cable temperature the cable loads of the other circuits originating at the Clover Bar substation should be taken into consideration at the same time.

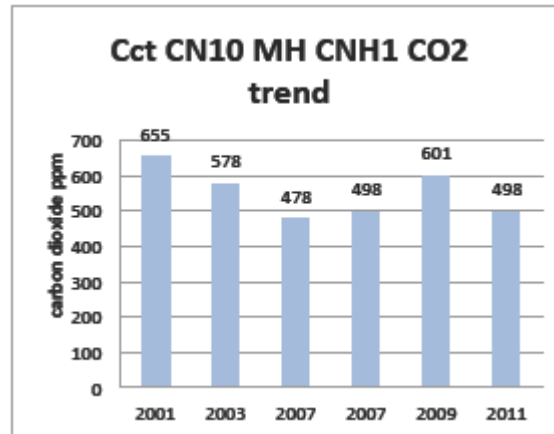
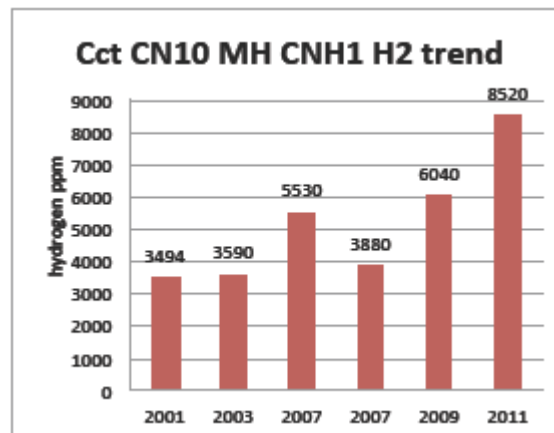
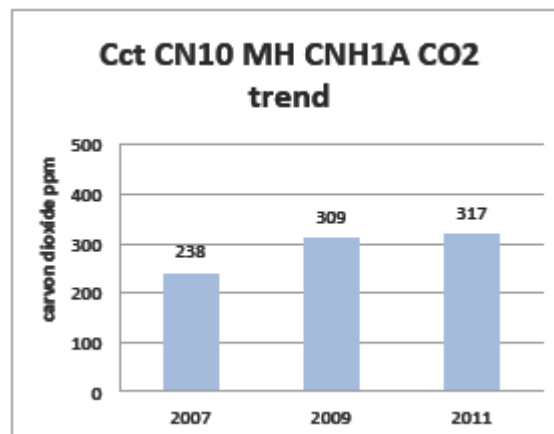
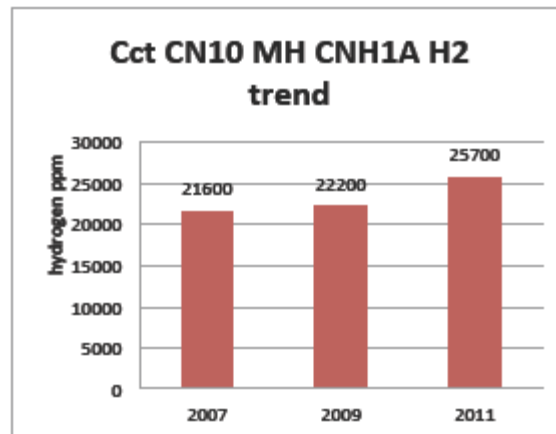
## Circuit 72CN10 Trends

This circuit contains moderately high hydrogen levels that appear to be clustered at sample points close to the circuit ends. The DGA values at the Cloverbar terminations are within the “action” range of the EPRI Guidelines. A sample taken in 2003 at the Namao trifurcator was at a level midway through the “concern” level. Samples taken in 2011 at manhole CNH1A were at similar level. Fluid sampling at the terminations in Namao Substation would be helpful in assessing the current condition of the circuit.

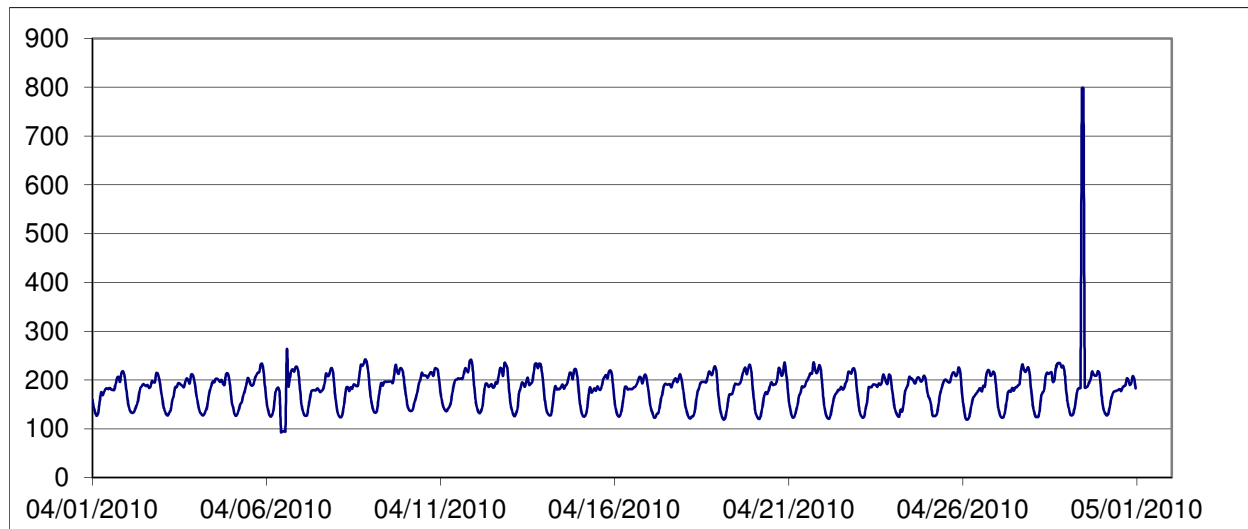
The load history was provided by EPCOR from Jan. 1999 to the present. In comparison to the rating in affect at the time there is no sign of circuit overloading. The maximum daily circuit does not exceed the circuit continuous rating except the spike shown on the chart. It happened in Jan 17, 2008 and again April 29, 2010. Such sudden increase of the cable load may have severe detrimental effect on the cable conditions.

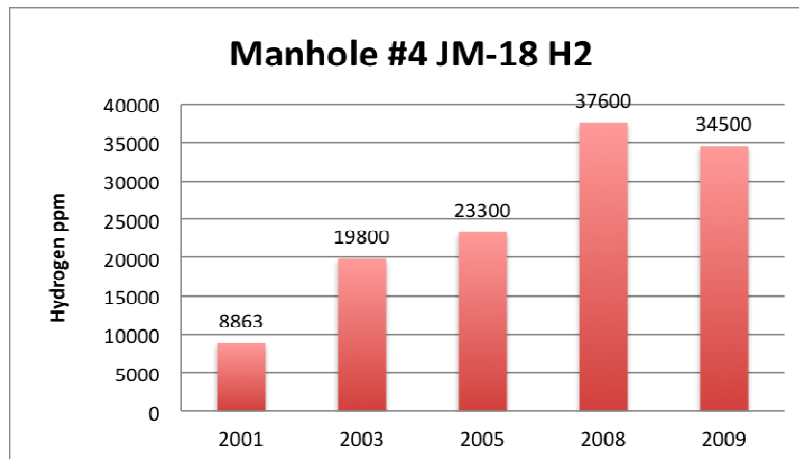
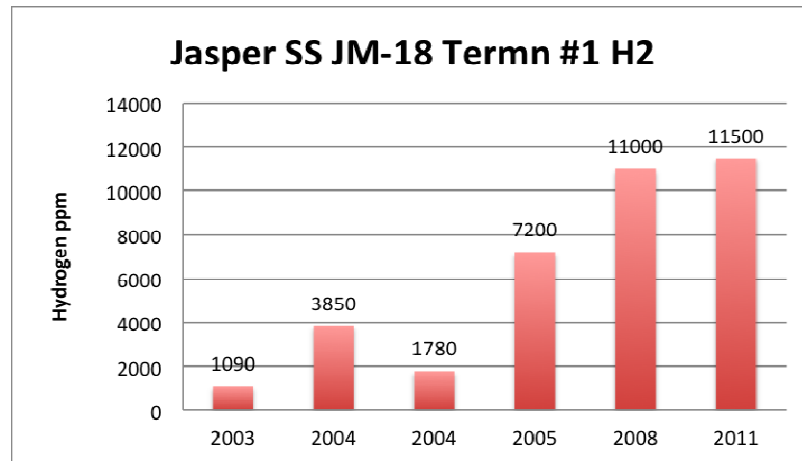
### Circuit 72JM18 Trends

The hydrogen concentrations from samples at manhole JM4 are close to the “action” level of the EPRI Guidelines. The reasons for the observed increases and decreases in some of the hydrogen and carbon dioxide concentrations are not obvious. It is possible that the trends were influenced by fluid movement associated with joint replacements carried out in 2005.

It is presumed that the reduction in hydrogen concentrations in 2004 at the Jasper terminations was the result of replacement of the fluid during the termination rebuilding. It is noteworthy that the rising hydrogen trend resumed in subsequent samples. Benefits resulting from the reported degassing of the Jasper terminations in the fall of 2010 could not be seen in the 2011 DGA results. These results therefore remain inside the EPRI “action” level.

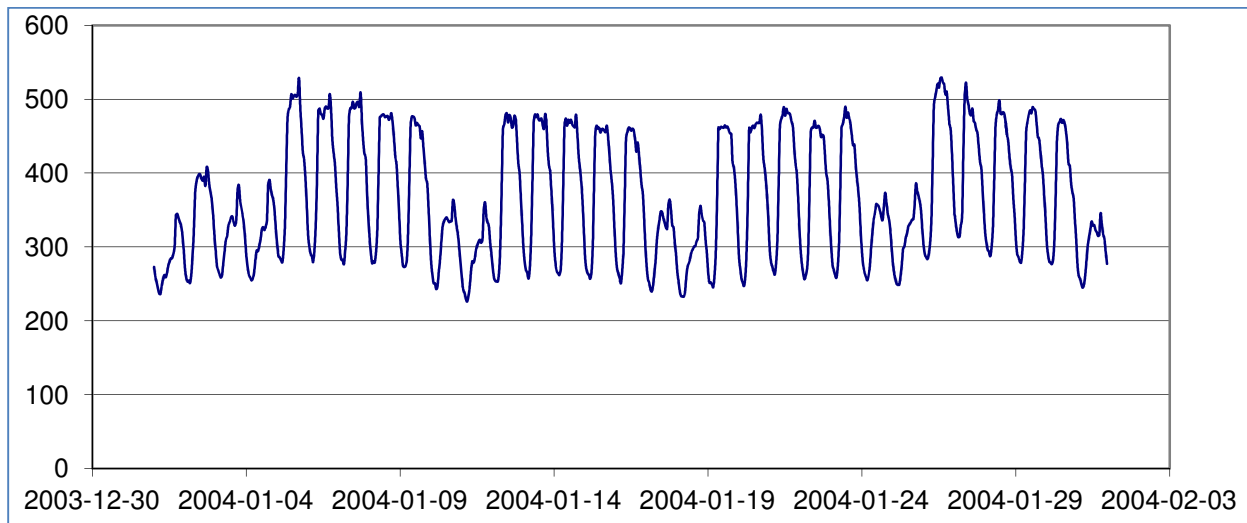
The load history was provided by EPCOR from Jan. 1999 to the present. There is no sign of circuit severe overloading according to the ratings applicable at the time. The maximum daily circuit load exceeds sometimes the circuit continuous rating. If those overloading occurred in the unfavorable conditions the cable overheating may be a reality. The frequency of the emergency load should not exceed the conditions described in the AEIC CS2-97 standard.

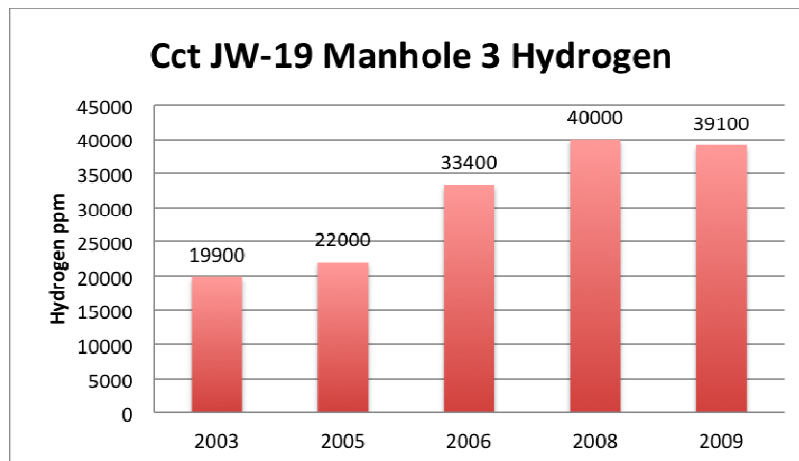
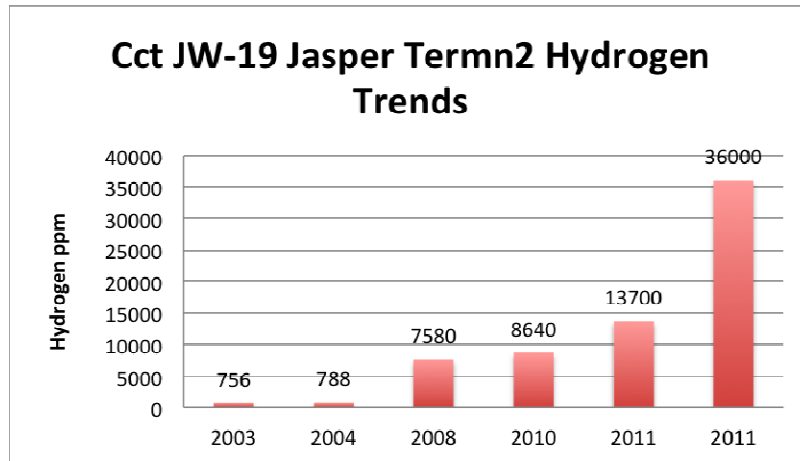
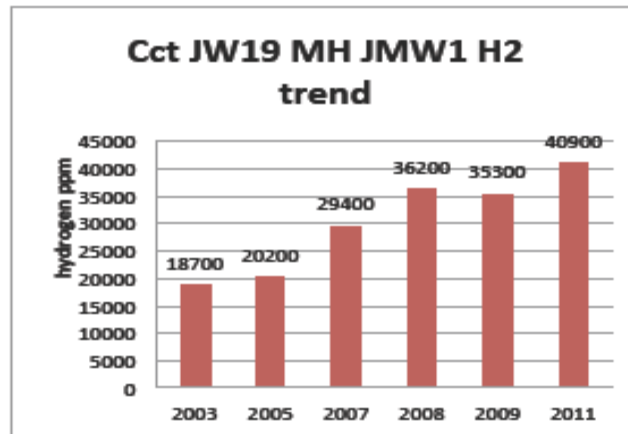
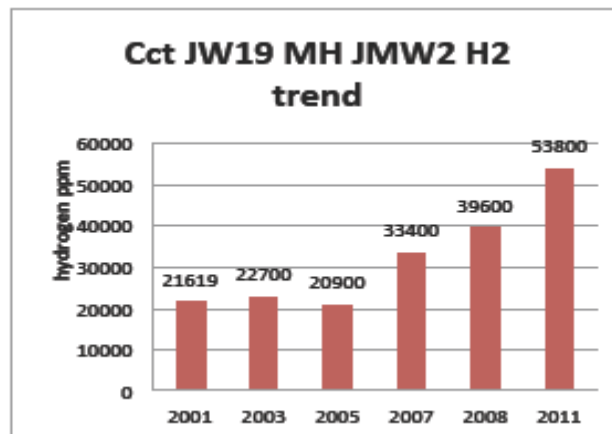
## Circuit 72JW19 Trends

The termination hydrogen levels are well into the “action” range of the EPRI Guideline. A rising trend in termination hydrogen is evident at the Jasper end of the circuit. . Despite the reported degassing in 2010, the Jasper hydrogen concentrations from 2011 appear higher than they were in the prior period. The last samples from the Woodcroft terminal end were taken in 2005, further sampling is recommended.

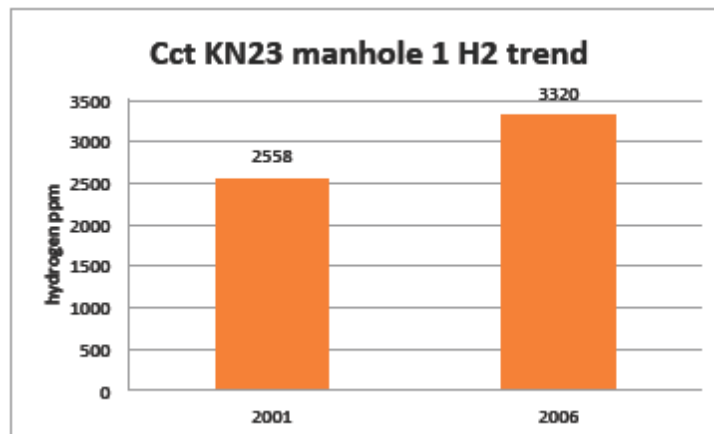
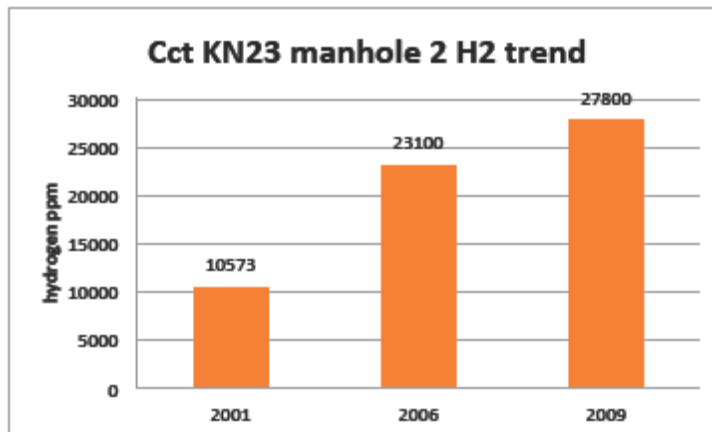
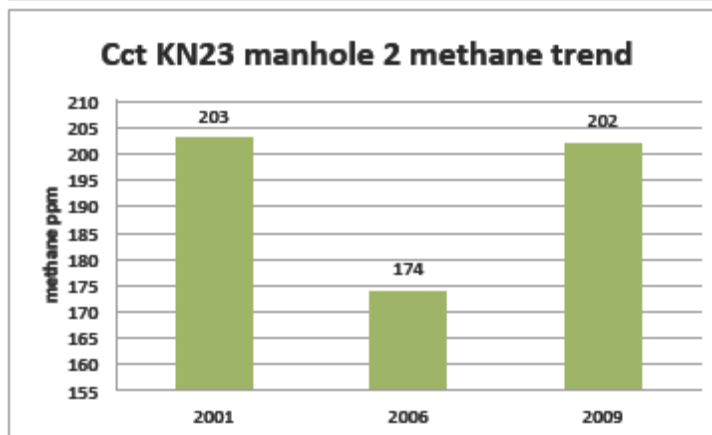
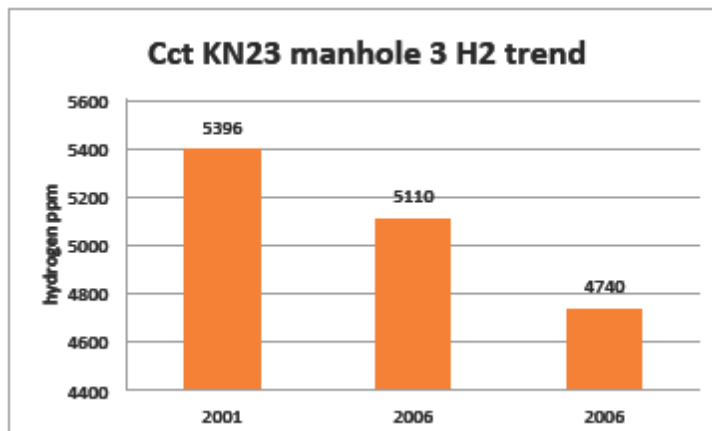
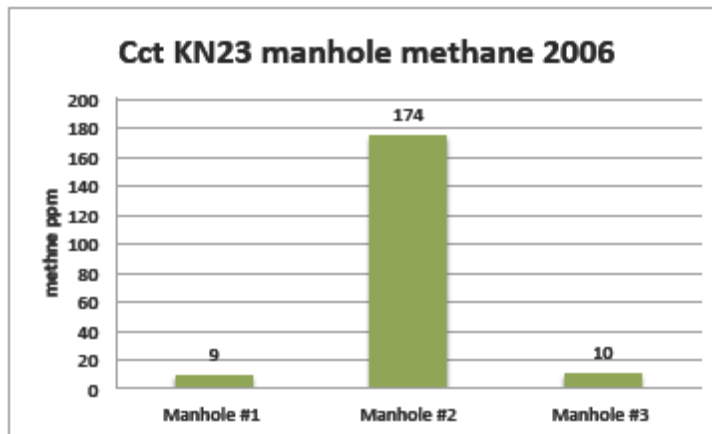
## Circuit 72KN23 Trends

Two of the 2011 Namao termination results are at the “action” level for hydrogen while all three samples are at “action” level for acetylene. Ethylene, methane, carbon monoxide and carbon dioxide are in “acceptable” range but higher than commonly seen in EPCOR DGA results. The results from the Kennedale terminations are in the “concern” range for hydrogen, but are much lower than at the Namao terminations.

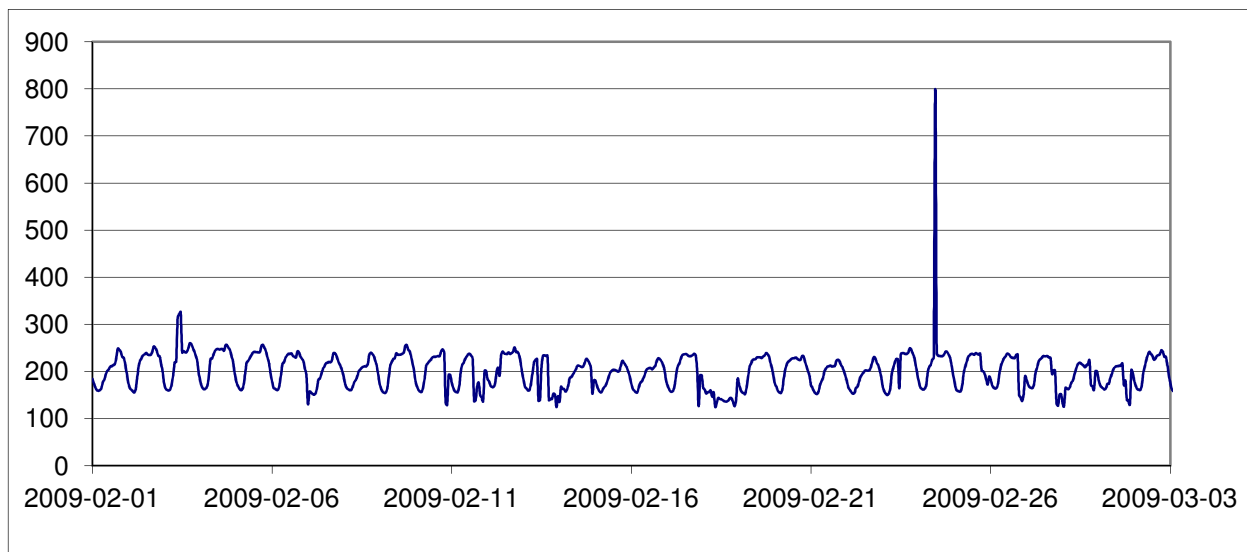
The load history was provided by EPCOR from Jan. 1999 to the present. There is no sign of circuit overloading. The maximum daily circuit load is within 50-60% of the continuous rating. The visible sudden increase of the load occurred on Feb 24, 2009 and reached 799A – reason unknown. Such sudden increase of the cable load above its maximum emergency rating is detrimental to the cable conditions.

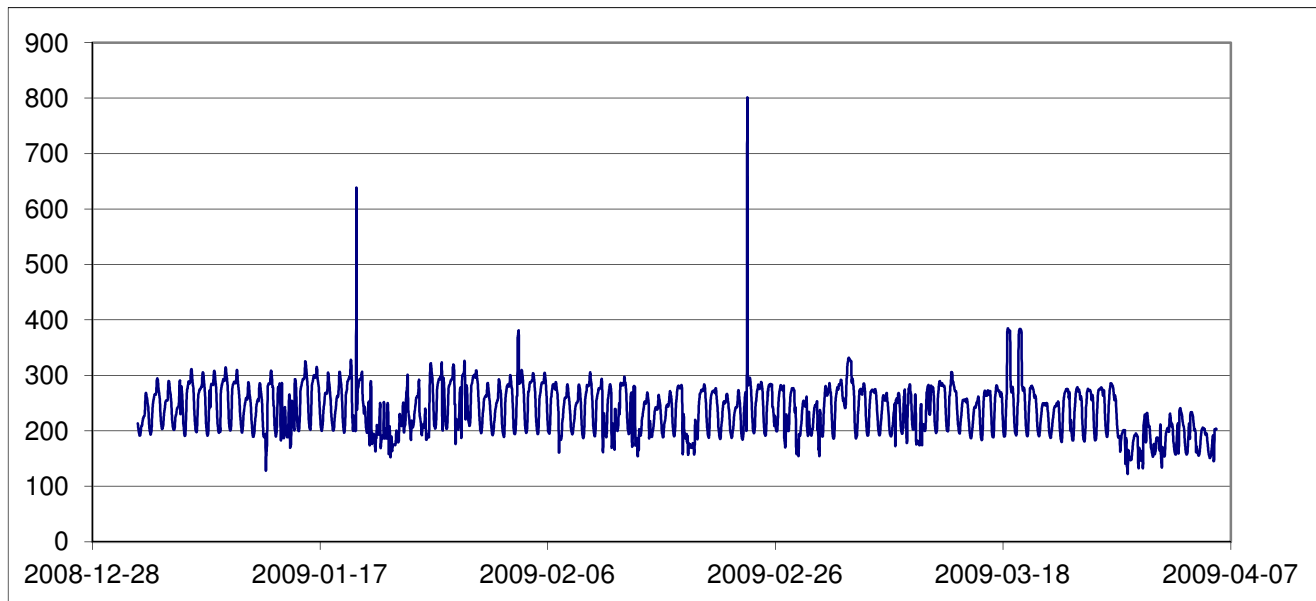
The load history was provided by EPCOR from Jan. 1999 to the present. There is no sign of circuit overloading. The maximum daily circuit load is within 40-50% of the continuous rating. The visible sudden increase of the load occurred on Feb 24, 2009 and reached 799A – reason unknown. It does not exceed the specified circuit emergency rating but such sudden increase in the cable load is detrimental to the cable conditions.

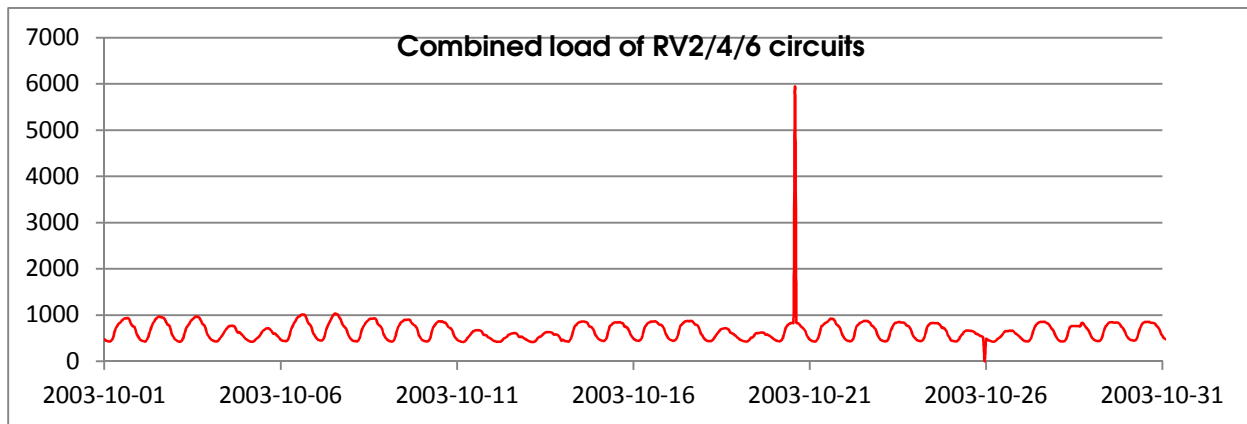
The load history was provided by EPCOR from Jan. 1999 to the present. The maximum combined load of all three circuits is shown below. The maximum load totaled to approx. 5,948A. The load was evenly distributed over all three circuits carrying 742MVA for a short period of time. The RV2 circuit load was 1,972A.

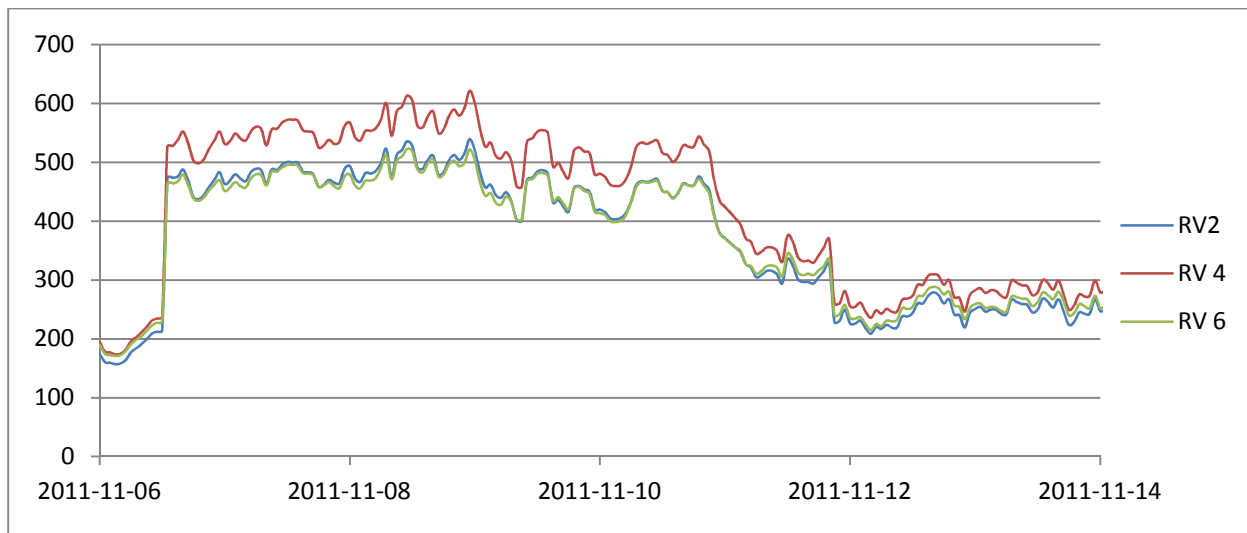
It was also found that the RV2 circuit was loaded over prolonged period of time as shown below. It shows that the cable combined load of three circuits exceeds the recommended 200MVA for four days:

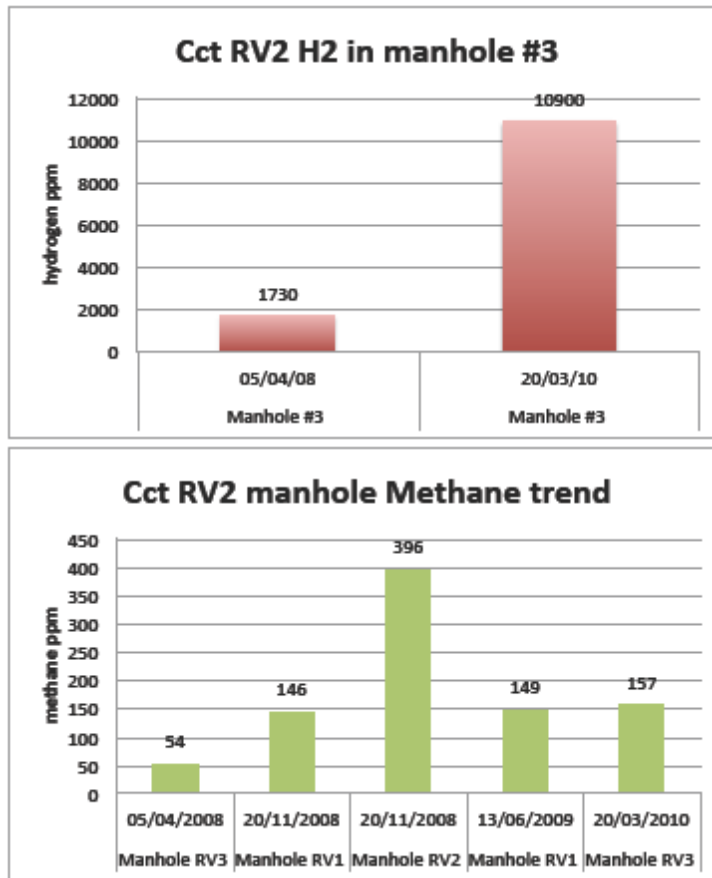
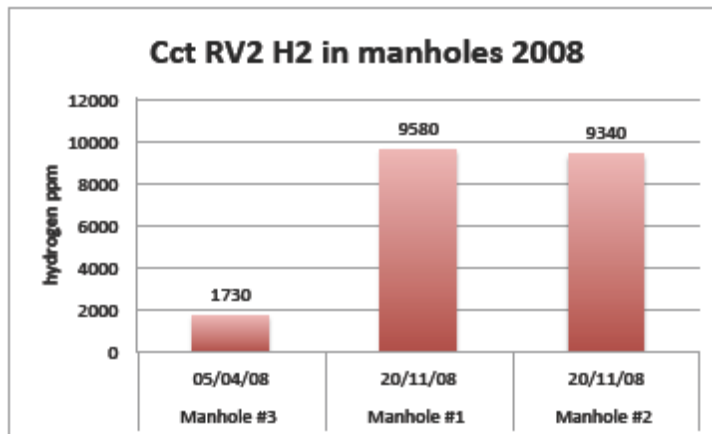
### Circuit 72RV2 Trends

The 2008 DGA results from the three manholes suggest that hydrogen generation is occurring at significant levels in this forced cooled circuit. The generally lower gas levels from the 2008 sample at manhole RV3 were likely to have been influenced by major construction activities that occurred at Victoria Substation. Despite the dilution effect of fluid circulation the methane values generally appear higher than for other EPCOR HPFF circuits. This suggests some thermally induced decomposition may have occurred in one or more of these circuits. A DGA sample in 2007 from the main tank of FOCS displayed similar levels of hydrogen and methane to those found at the manholes.

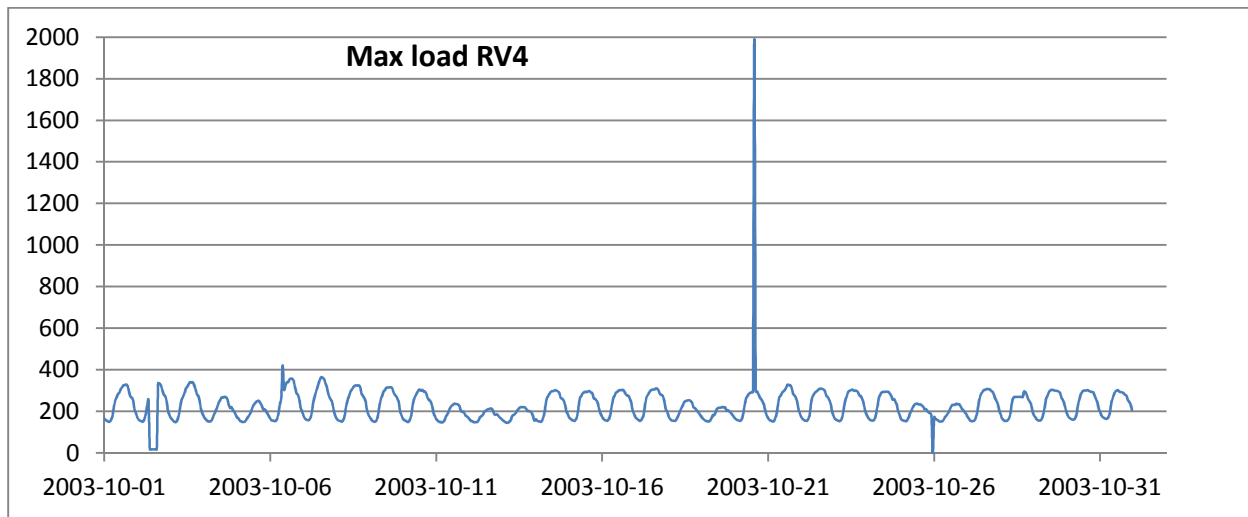
The load history was provided by EPCOR from Jan. 1999 to the present. The maximum load of RV4 circuit is shown below. The maximum load totaled to approx. 5,948A. The load was evenly distributed over all three RV circuits. The RV4 circuit load was 1,972A for a short period of time.

The analysis of the load pattern does not indicate any overloading of this circuit because the conductor size is the largest out of the three circuits being cooled with one common fluid circulating system. However, the short period overload as shown on the graph has a detrimental effect on the quality of insulation.

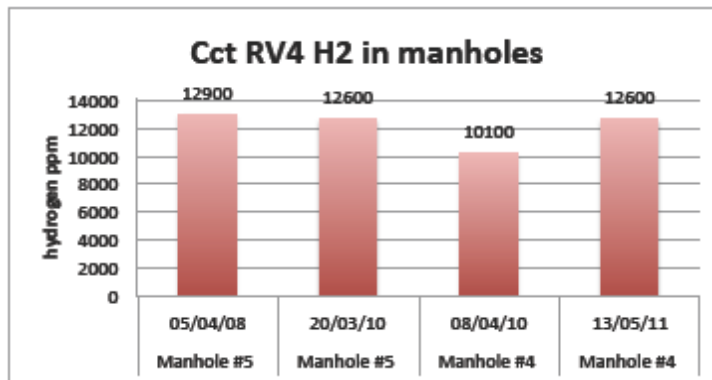
## Circuit 72RV4 Trends

The 2008, 2010 and 2011 DGA results from the two manholes suggest that hydrogen generation is occurring at significant levels in this forced cooled circuit. The methane values also appear higher than for other EPCOR HPFF circuits, particularly with the dilution effect of fluid circulation. This suggests some thermally induced decomposition may have occurred in one or more of these circuits. A DGA sample in 2007 from the main tank of FOCS displayed similar levels of hydrogen and methane as those found at the manholes of these circuits.

The recent opening of the pipe at the MH#4 joint revealed a significant amount of charred insulating paper. Since the cable was not subjected to a fault in the past the charred paper might originate at different circuit, possibly RV2. An investigation should commence promptly to find the reason of the contamination. The combination of the complementary parameters of the moisture and DP indicates that the serious aging occurred. This is considered a high risk circuit.

- Complete degassing of the fluid in this system would allow DGA trending to be effectively carried out without the results being excessively influenced by past events;
- The gas level should be monitored as a part of the hydraulic section (RV2/RV4/RV6). The details of the tests are applicable to all 72RV circuits because the oil is continuously circulated.
- The paper insulation tests shall be performed as soon as possible after opening of the new rehabilitation joint and through testing of this circuit shall be performed. The recommended PD test shall be performed before the circuit is stressed with another DC withstand test. Note that the proposed PD test can be considered also as the AC withstand test.

- Because of the recent discovery the fluid in the circuits 72RV2, 72RV4 and 72RV6 should be flushed through a filter and degasser to remove traces of burnt material after the joint rehabilitation is complete. After the filtering all filters in the hydraulic system should be replaced.
- Soil tests in the vicinity of crossing with RV6 are strongly recommended. After testing the soil samples from this location and taking into consideration the past circuits loads it will be possible to estimate the cable temperature.
- Temperature testing station with temperature sensors connected to the RV4 & RV6 pipes at the crossing location should be considered.
- PD and  $\tan \delta$  test is recommended.

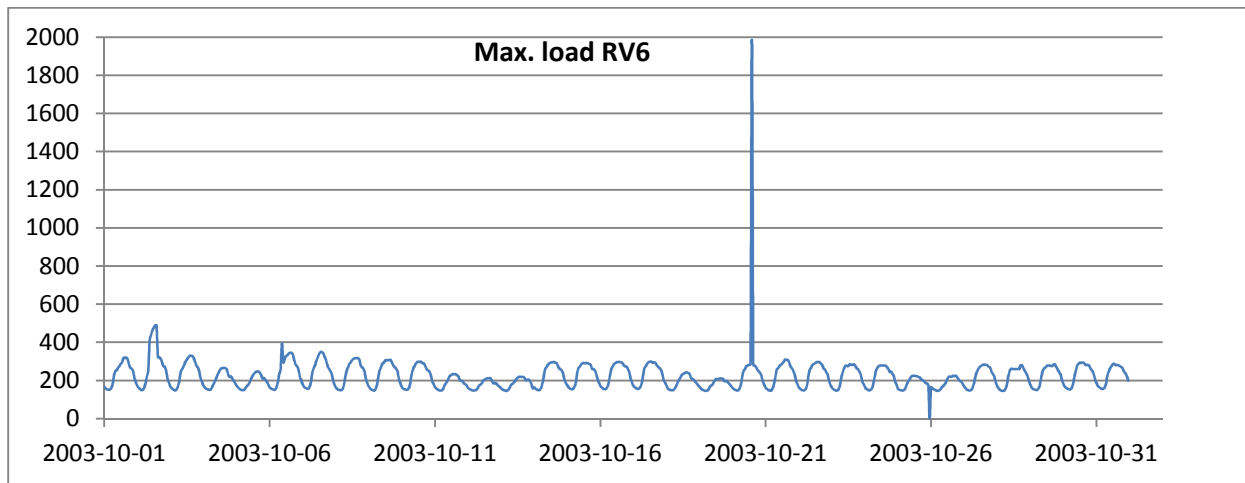
The load history was provided by EPCOR from Jan. 1999 to the present. The maximum load of RV6 circuit is shown below. The maximum load totaled to approx. 5,948A. The load was evenly distributed over all three RV circuits. The RV6 circuit load was 1,972A for a short period of time.
