## EDTI ASSET ASSESSMENT – MAJOR EQUIPMENT KENNEDALE SUBSTATION

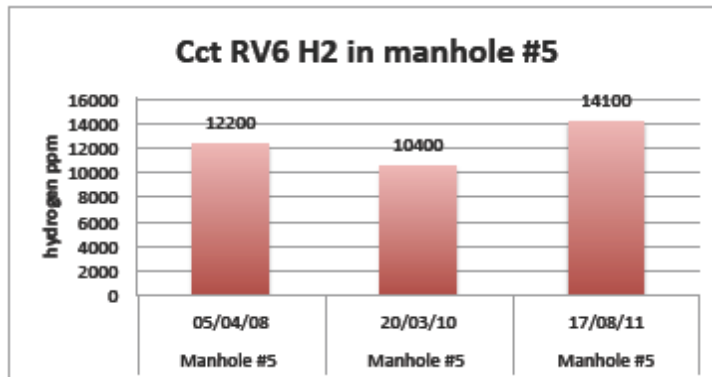
## Circuit 72RV6 Trends

The 2008, 2010 and 2011 DGA results from the two manholes suggest that hydrogen generation is occurring at significant levels in this forced cooled circuit. The methane values appear higher than for other EPCOR HPFF circuits, despite the dilution effect of fluid circulation. This suggests some thermally induced decomposition may have occurred in one or more of these circuits. A DGA sample in 2007 from the main tank of FOCS displayed similar levels of hydrogen and methane as found at the manholes of these circuits. Two of the three samples taken from the Victoria terminations in 2011 had hydrogen concentrations at the “concern” level. It is presumed that the excellent DGA results at the third termination had been influenced by the major work undertaken there in 2011.

This circuit has been relocated and reconnected a few times. It is very difficult to assess its conditions as the fluid is circulated through RV2 and RV4 and the gasses are averaged by the liquid movement. The paper test indicated normal aging conditions. Low risk at this time.

- The paper insulation tests shall be performed as soon as possible after opening of the new rehabilitation joint and through testing of this circuit shall be performed. The recommended PD test shall be performed before the circuit is stressed with another DC withstand test. Note that the proposed PD test can be considered also as the AC withstand test.

- Because of the recent discovery the fluid in the circuits 72RV2, 72RV4 and 72RV6 should be flushed through a filter and degasser to remove traces of burnt material after the joint rehabilitation is complete.

- PD and  $\tan \delta$  test is recommended.

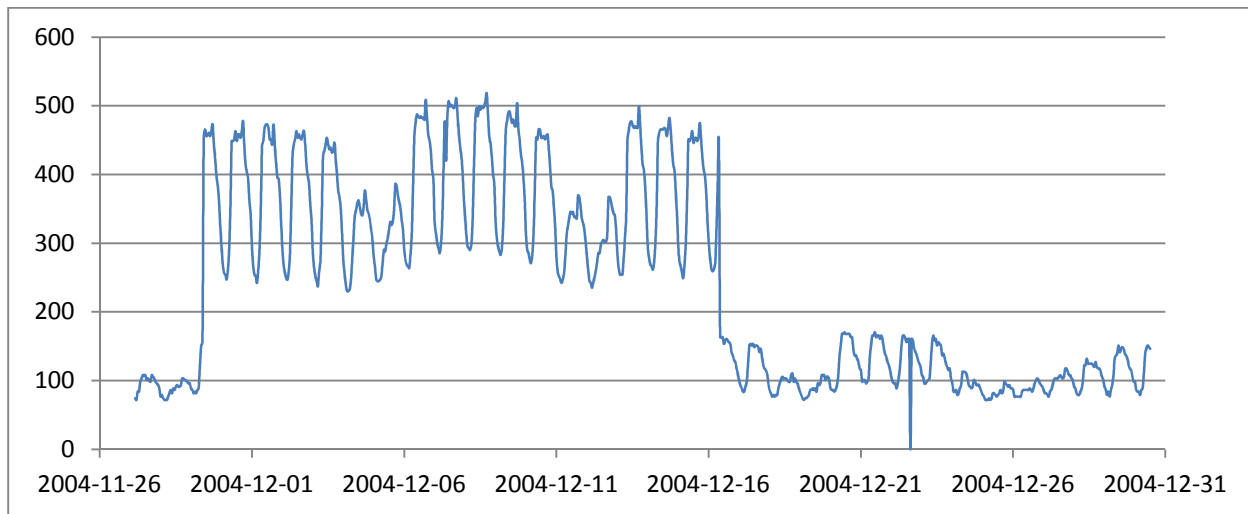
The load history was provided by EPCOR from Jan. 1999 to the present. The cable runs sometimes at maximum allowed ratings. If compared the newly calculated ratings the circuit seems to be overloaded at times.

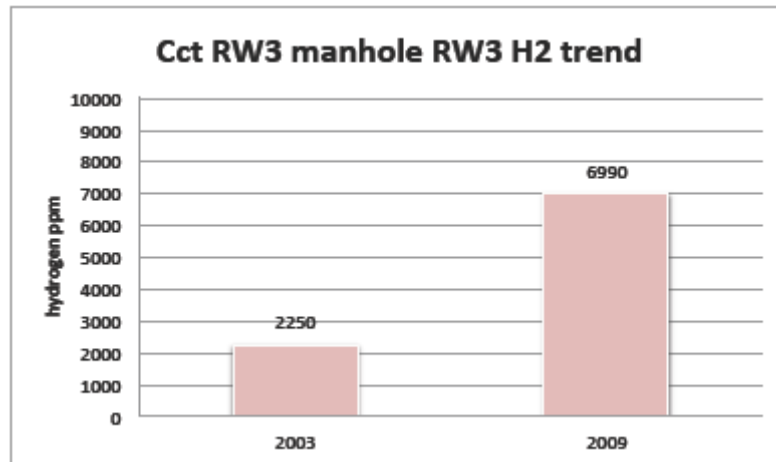
### Circuit 72RW3 Trends

No samples from the terminal ends were present in the database. It would be advisable to get DGA samples at each end of the circuit.

The risk cannot be assessed for this circuit as there is no sufficient number of test results. The insulation test did not indicate any excessive deterioration but the DGA registered significant increase of hydrogen amount at the same location.

- Another insulation paper test should be performed by an acceptable laboratory and DP test results compared. The testing laboratory should be the one that the company is comfortable with. Since the obtaining the samples may not be possible within a short timeframe the alternative partial discharge test can be the best solution;
- Soil samples should be taken and analyzed;
- Annual DGA testing should be performed at the manholes and terminal ends;
- PD and  $\tan \delta$  test is strongly recommended;

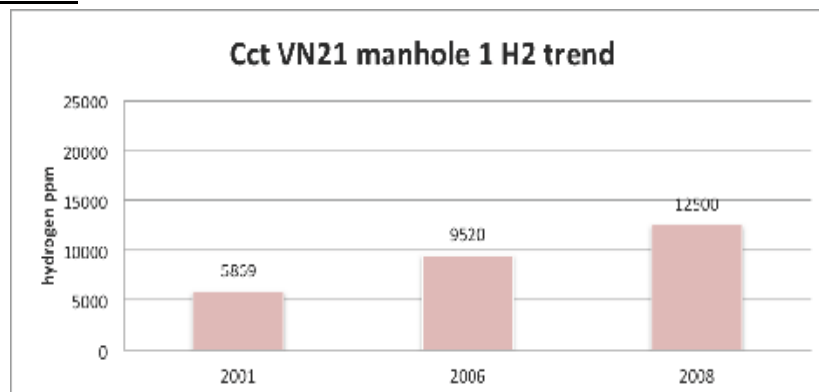
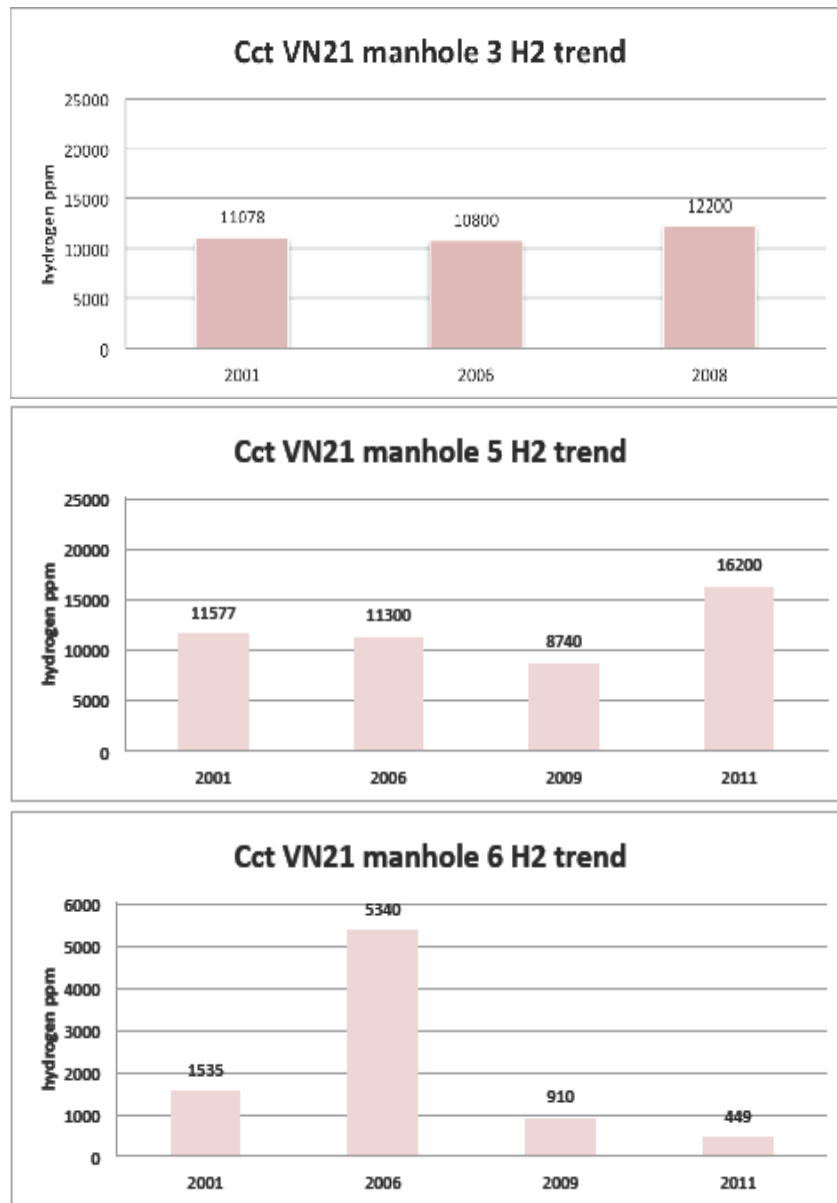
### Circuit 72VN21 Trends

Major work was done on this circuit in 2008, 2009 and 2011. It is probable that the acetylene found in 2011 samples at manholes NV5 and NV6 may be related to fluid movement associated with this work. The increases in methane at manholes NV4 and NV5 may also be related to fluid movement and may indicate that some low-level thermal decomposition has occurred somewhere within the cable system.

The latest paper tests conducted in May 2011 revealed significant deterioration of the dissipation factor. The DP factor of the layers close to the conductor in all three phases is lower than other layers that indicates

thermal damage in VN1 location. It is reasonable to expect that the other locations are in similar conditions. The sample extracted in 2011 from VN2 location also generally confirmed aging. The dissipation factor at both locations is within the range of 0.93-1.51%. Since the moisture level is high, but not excessively high, we can assume that the increased dissipation factor and reduced polymerization factor are caused by severe deterioration.

- The circuit should be monitored very closely and a paper sample should be obtained from all three phases at other locations as soon as possible.
- DGA sampling should be done at six month intervals at manholes NV4 and NV5 so that and the overall trend of combustible gases can be monitored.
- PD and  $\tan \delta$  test should be done to confirm or eliminate causes of the gassing in the manholes that exhibits the concern level of the combustible gases.
- Annual DGA sampling should be done at the other manholes and terminal ends.

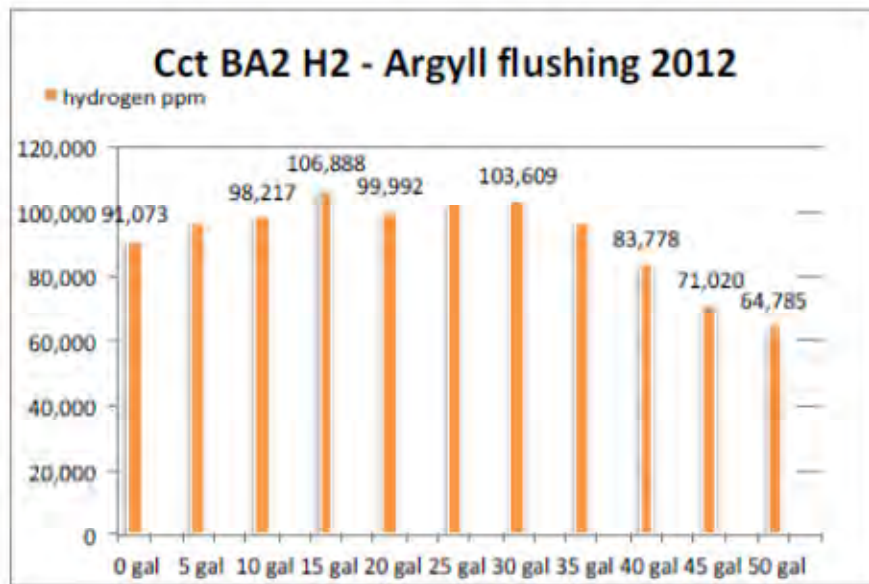
- The flushing of the BA2 circuit in April 2012 revealed that the highest concentration of gasses was between bottom of Argyll terminations and MH#7. The peak values occurred after a volume of 15 to 30 gallons was flushed. This places the location of peak hydrogen quite close to the cable terminal ends. The variation in hydrogen levels during this flushing are shown in the following graph:

Levels of the other telltale gases during the flushing were all extremely low and stable. Maximum values are shown below:

- Acetylene 4.9ppm;
- Carbon monoxide 17ppm;
- Carbon dioxide 161ppm;
- Methane 5.3ppm;
- Ethane 3.2ppm;
- Ethylene 2.4ppm;

EDTI proposes to replace life cycle replacement of the BA2 cable pipe, riser, and accessories at the Argyll station beginning in 2014. Ideally, partial discharge testing would be performed on this circuit as an additional input to the decision process.

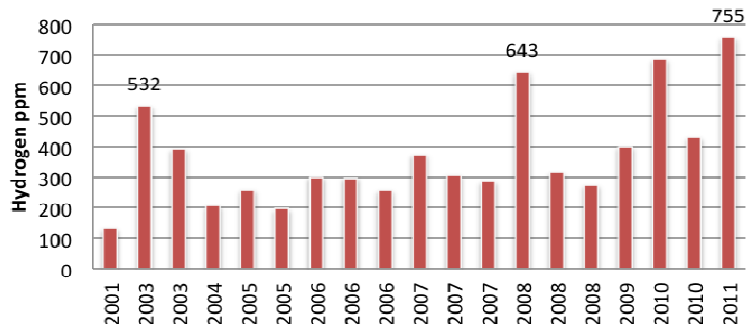
### Cct BA-2 Bellamy Pothead 1 Hydrogen

- In general, the hydrogen concentrations at manholes beyond the zone of influence of either substation are relatively low.
- The overall results from the EPCOR BA2 and BA3 sampling program shows that peak values of hydrogen consistently occur at the Argyll Substation termination system and at manholes 1 and 2. These two manholes are the closest to Bellamy Substation.

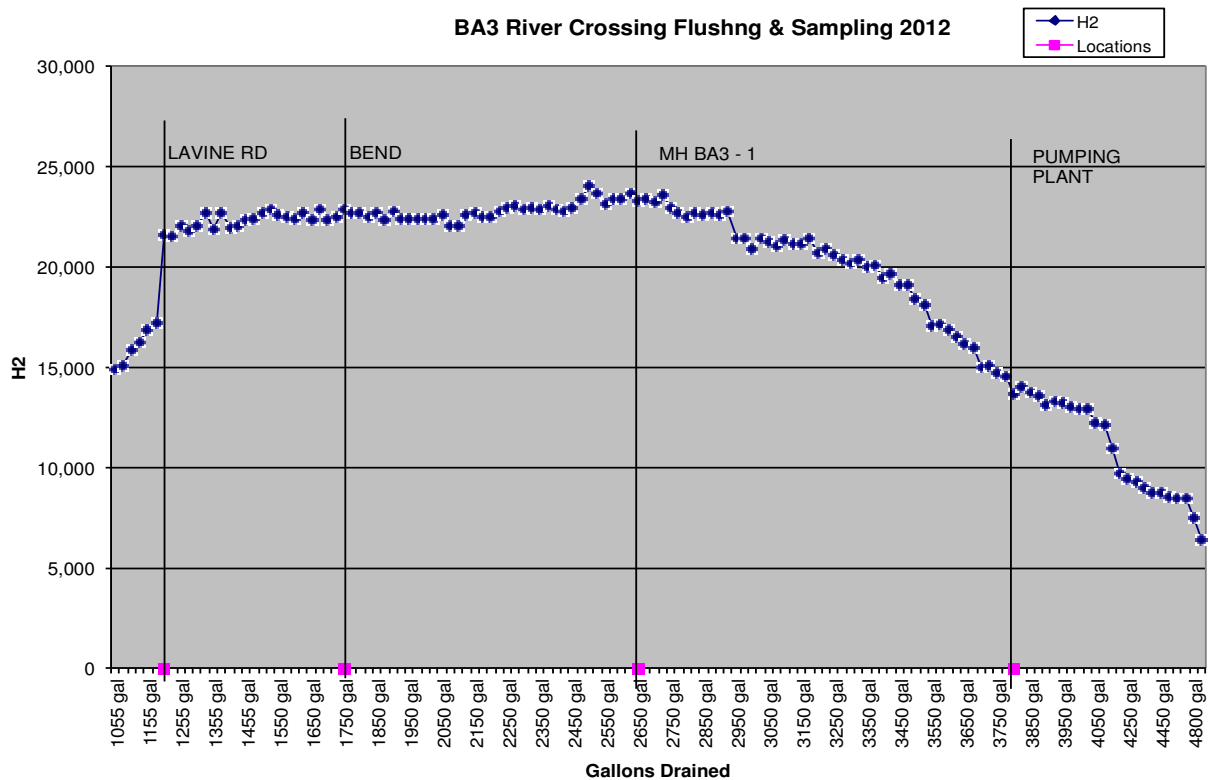
Flushing performed at manhole #1 in March 2012 showed that the peak hydrogen values near Bellamy SS to be at the river crossing. This is shown in the following graph:

In general, the hydrogen concentrations at manholes beyond the zone of influence of either substation are relatively low. The hydrogen concentrations are somewhat high at manhole 4. These are not consistent with the trends from manholes 3 or 5. They also differ with the circuit BA2 trends at this part of the route. Ideally, partial discharge testing would be performed on this circuit as an additional input to the decision process.

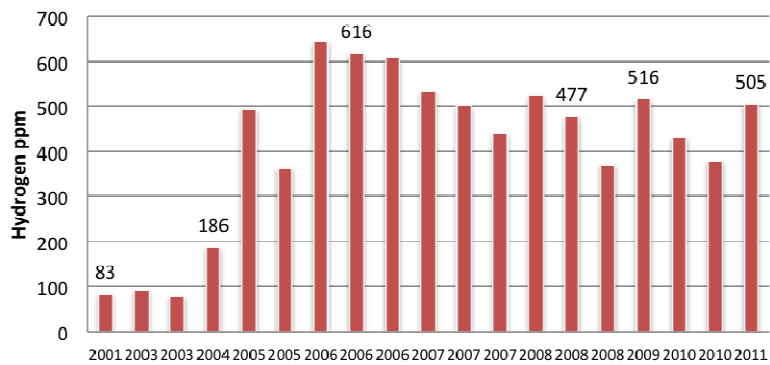
### Cct BA-3 Bellamy Pothead 3 Hydrogen

As with circuit 240BA2, the terminal ends at Argyll Substation have the greatest tendency to produce hydrogen. There is a significant contrast between the hydrogen levels at the Argyll end and the results from samples at the Bellamy SF6 terminations. Samples taken from the two manholes closest to Bellamy Substation have consistently shown the highest hydrogen concentrations from all the manholes.

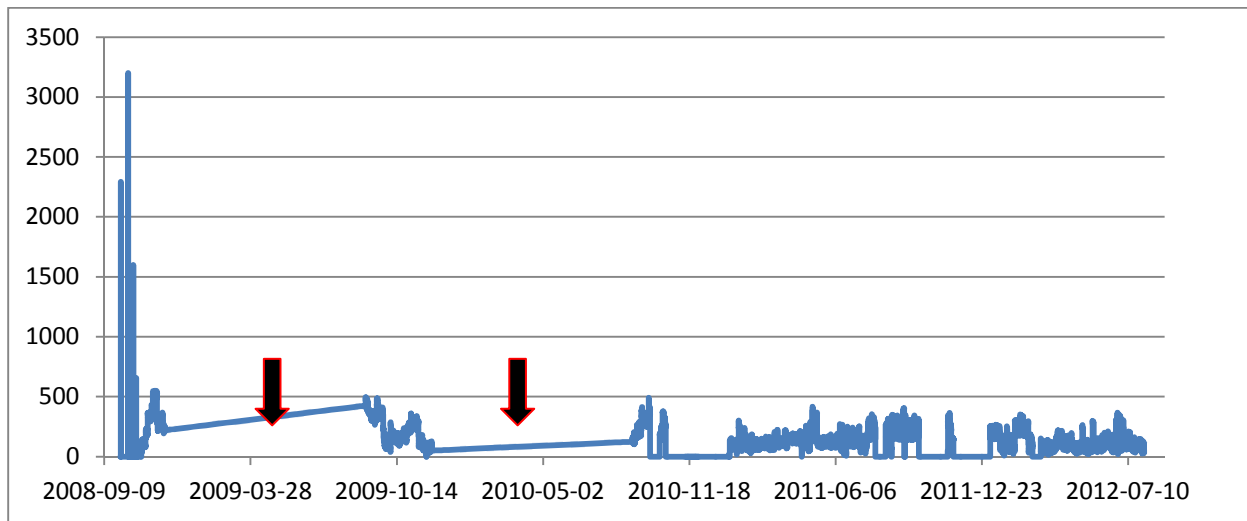
The load history is available from the circuit commissioning. There is no indication that the circuit current exceeded its design load.

Note: the load history is not continuous. There are two periods indicated by arrows when the data is not available. The circuit was out of commission.
